Oak Lodge Water Services District

Total Maximum Daily Load (TMDL) Implementation Plan

Annual Status Report

Rapid Bio-Assessment Report

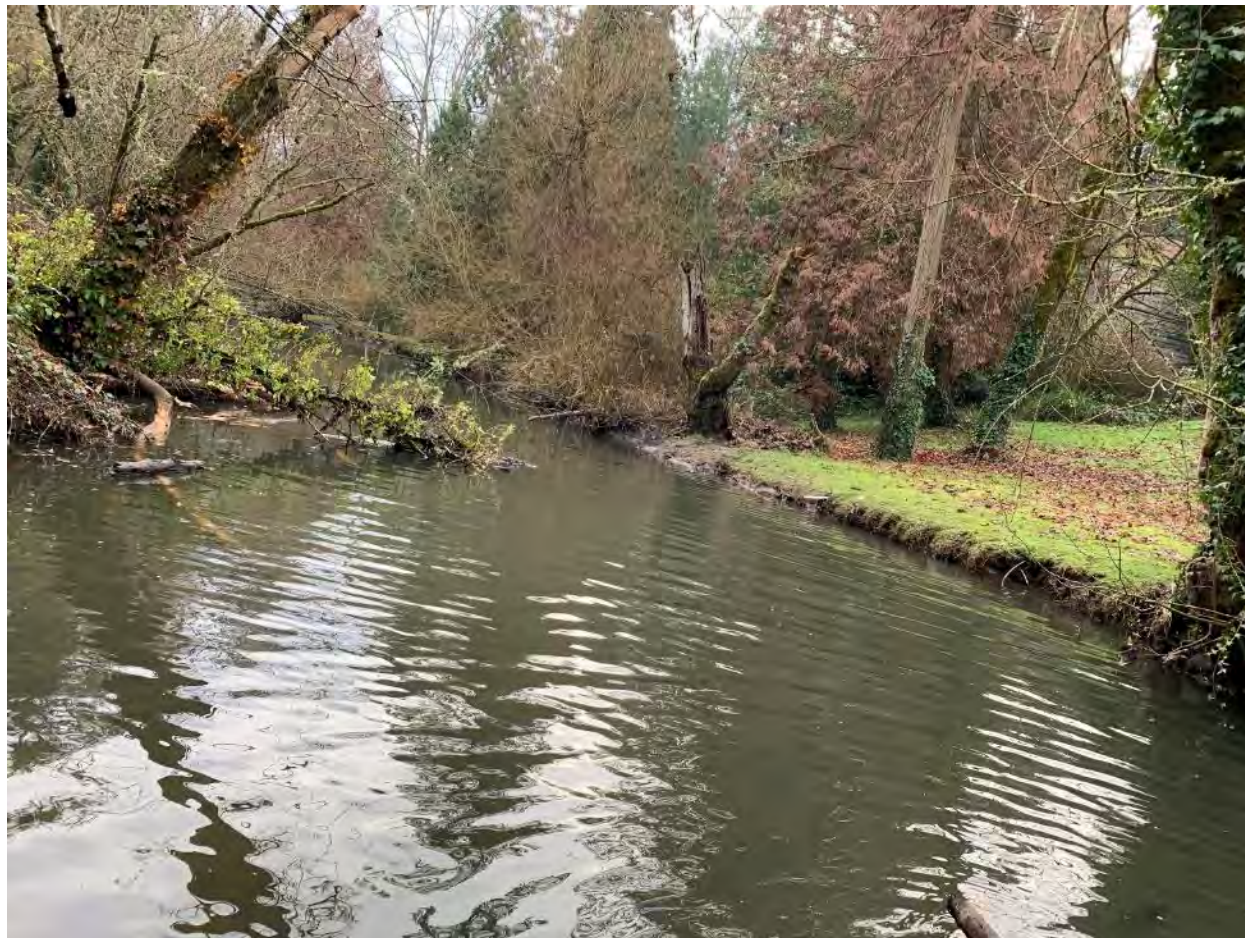
Pool quality for salmonid habitat was generally low, with an average pool complexity rank of 1.1 (scores may range from 1 to 5). Only one pool received a score of 2, and no pools were ranked higher than 2. Pool cover was low, with an average of only 4.5% cover for the reach and a maximum of only 15% cover in two of the 17 pools.

Figure 11. Pool unit that received the highest complexity rating within the surveyed portion of Kellogg Creek reach 1 (looking upstream). Note presence of minor large wood on river right bank.

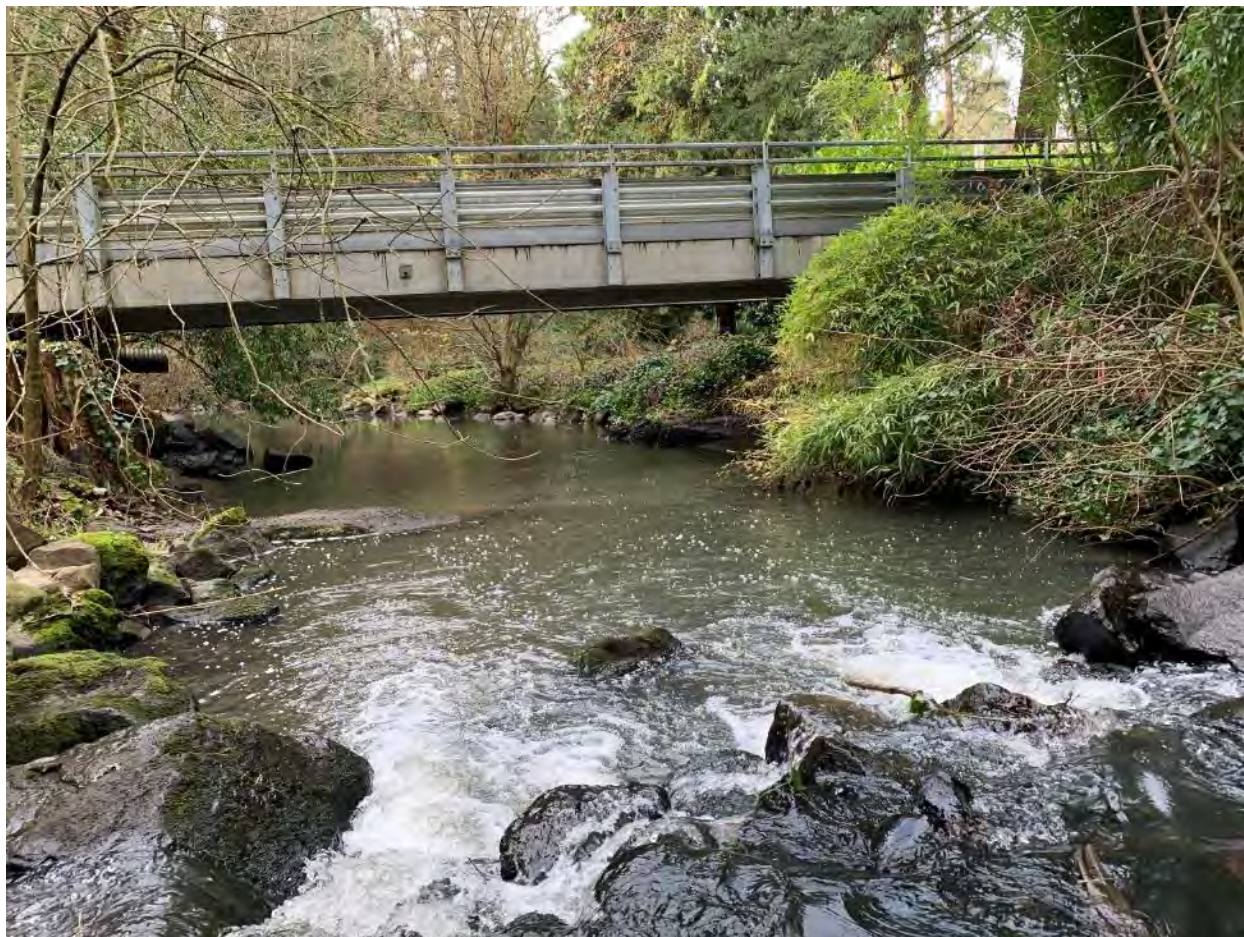
Stormwater infrastructure was also noted just upstream of the Keuhn Road crossing. At this location, a manhole is present at the edge of the river right channel and a pipe outlet was noted in the middle of the wetted channel (Figure 19). It is unclear the purpose of this pipe outfall. Large angular rock, riprap, appears to have been placed in the channel in this location, likely to protect the pipe infrastructure that may run across the channel. This riprap/pipe is noted as a barrier by ODFW (Barrier No. 34026).

Figure 18. Keuhn Road bridge crosses the channel near approximately rKm 3.55.

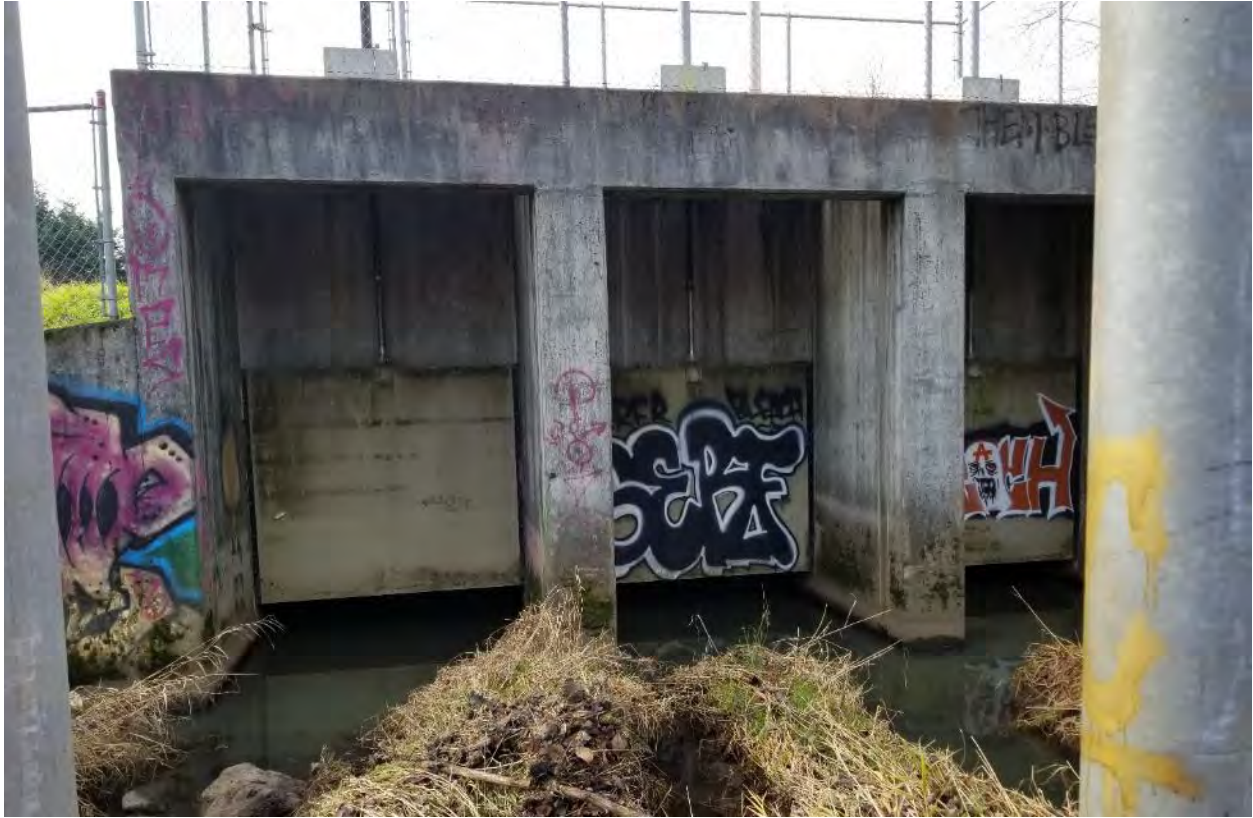
Figure 30. Water control structure gates at rKm 2.2 in MSC Reach 3.

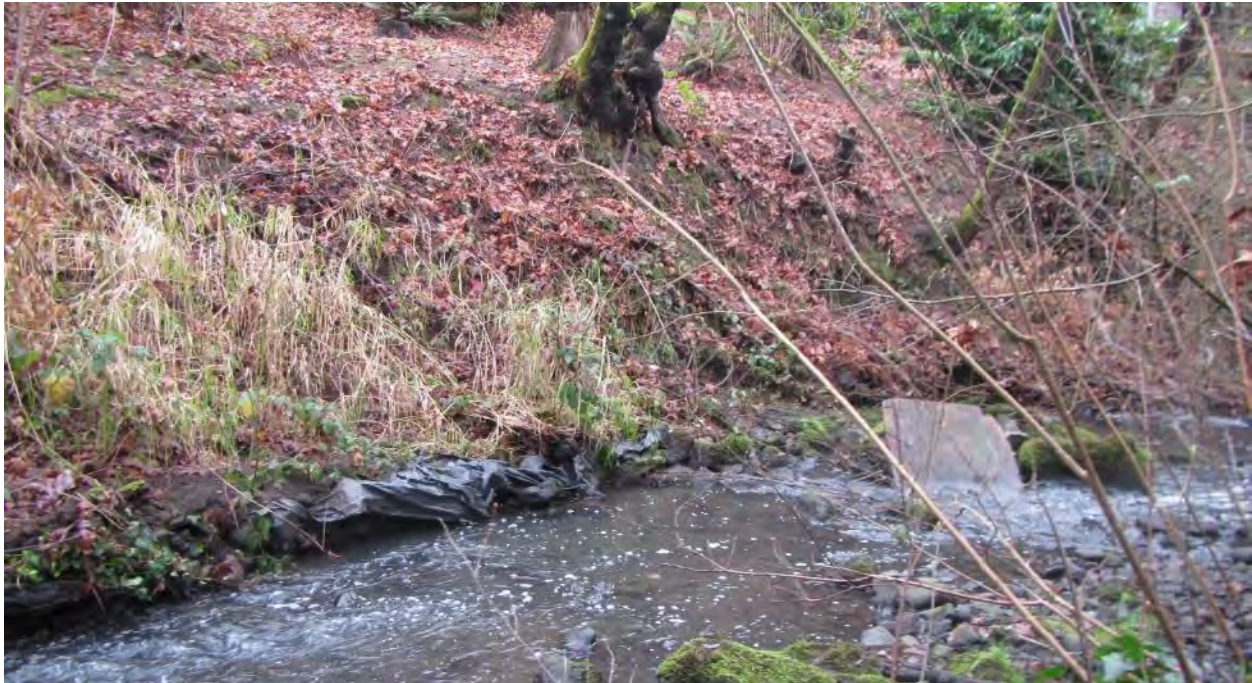
Figure 51. Minor bank erosion (and plastic sheeting along bank, presumably to limit additional erosion) noted along river left bank of Boardman Creek within the reach.

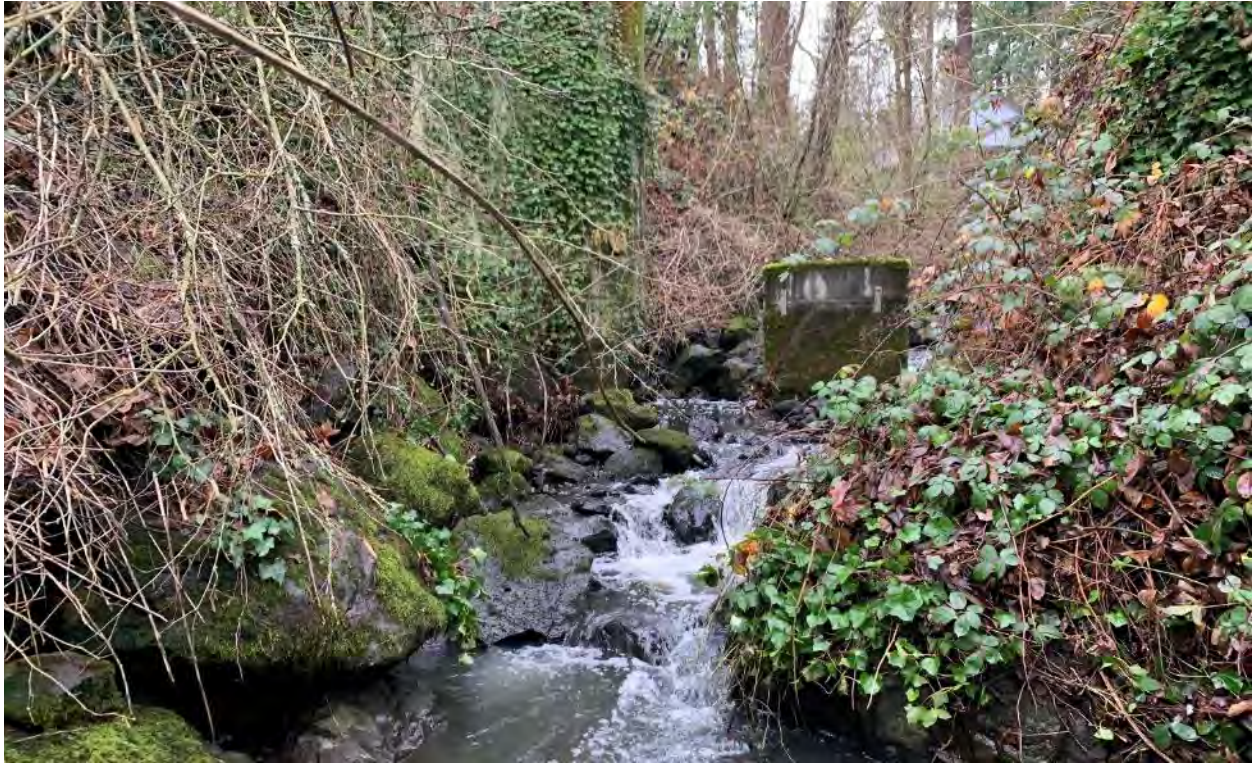
Figure 60. Standing in Boardman Creek and looking upstream at the bedrock cascade habitat unit and the manhole located in the center of the wetted channel at approximately rKm 0.1.

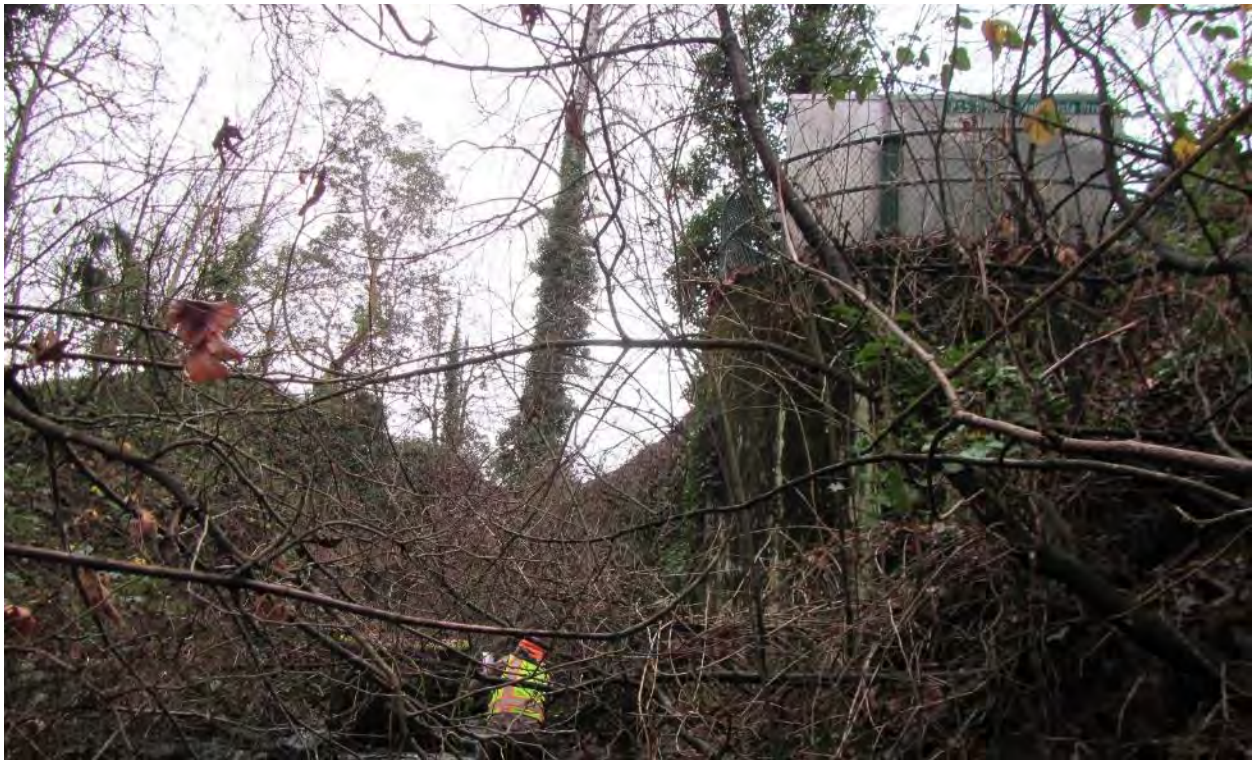
Figure 61. Standing in Boardman Creek and looking downstream at the large stormwater/sewerline infrastructure located on the river right bank near approximately rKm 0.1.

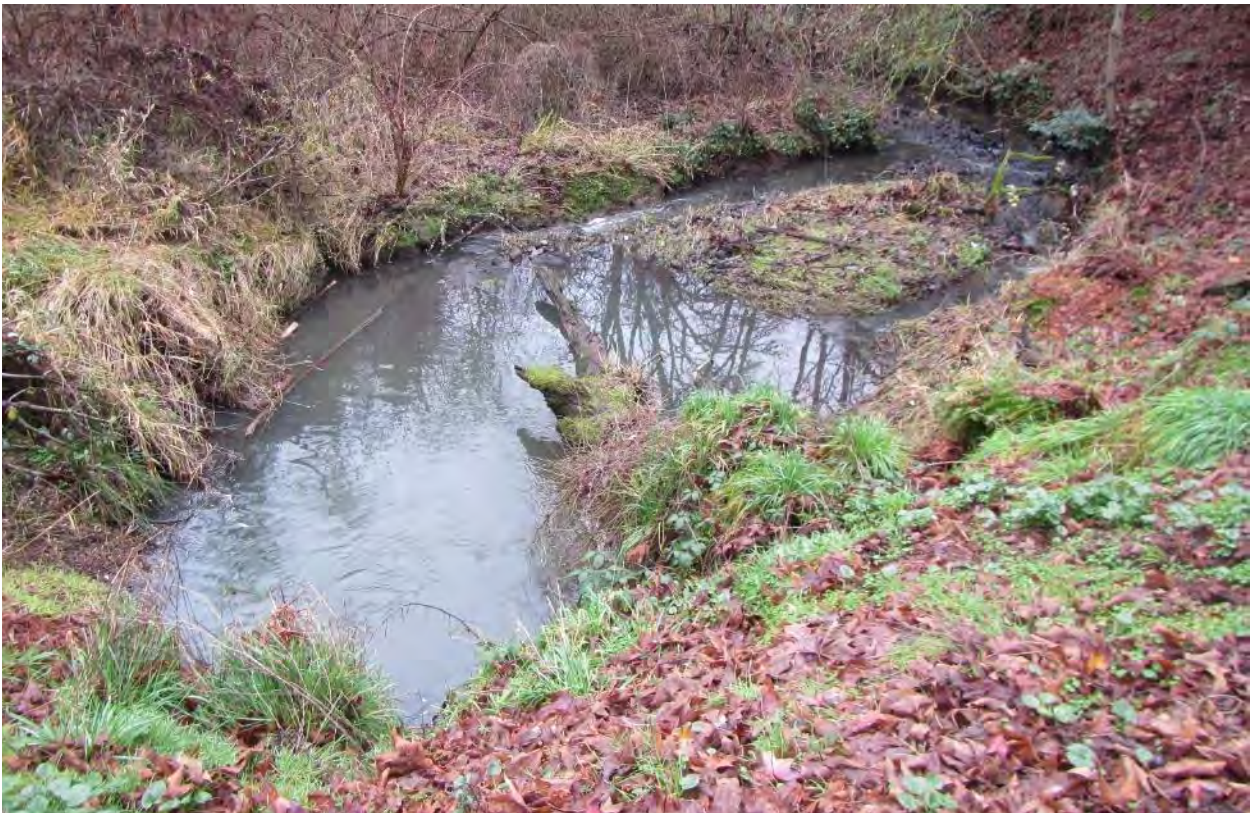
Figure 64. Boardman Creek from SE Walta Vista Rd (looking downstream at reach). Potential fish habitat is present in this reach, if it is accessible to fish. Upstream of this road culvert is inaccessible.

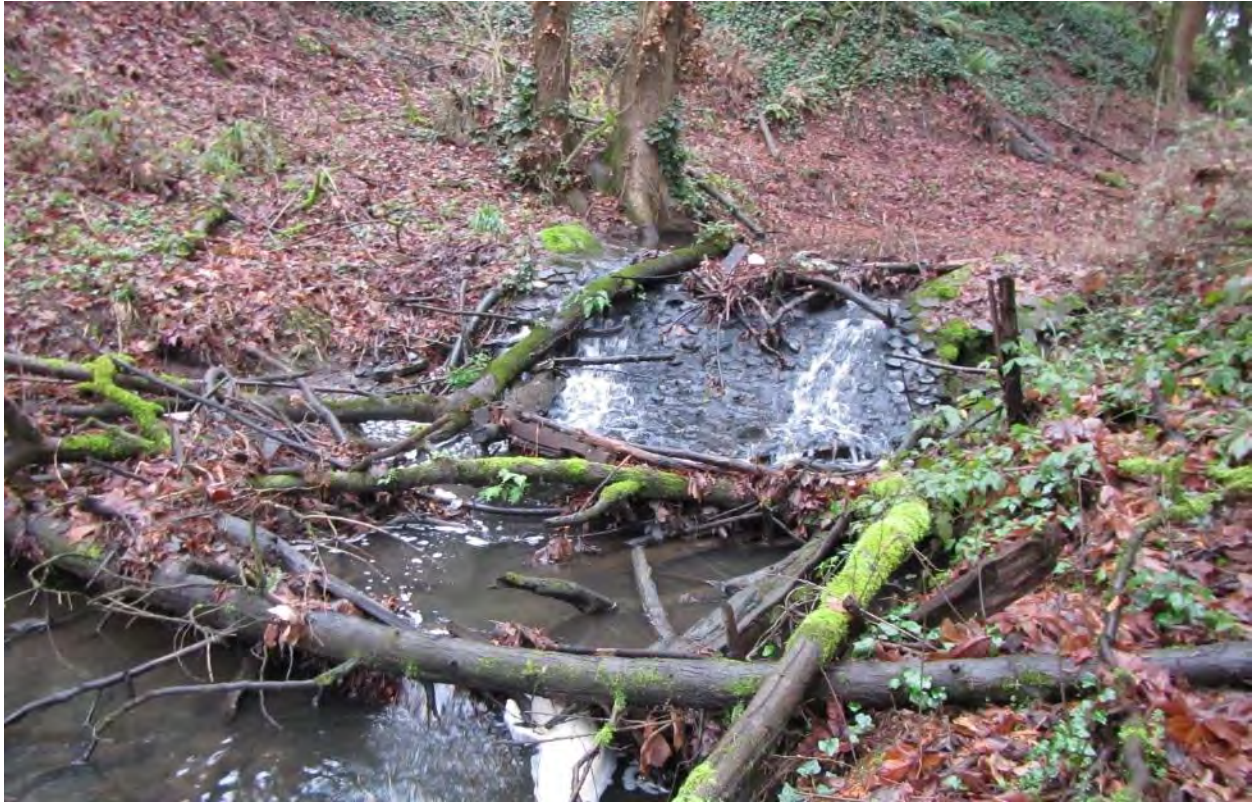
Figure 75. Manmade fish passage barrier in Rinearson Creek at rKm 0.7 (the upstream extent of the survey area).

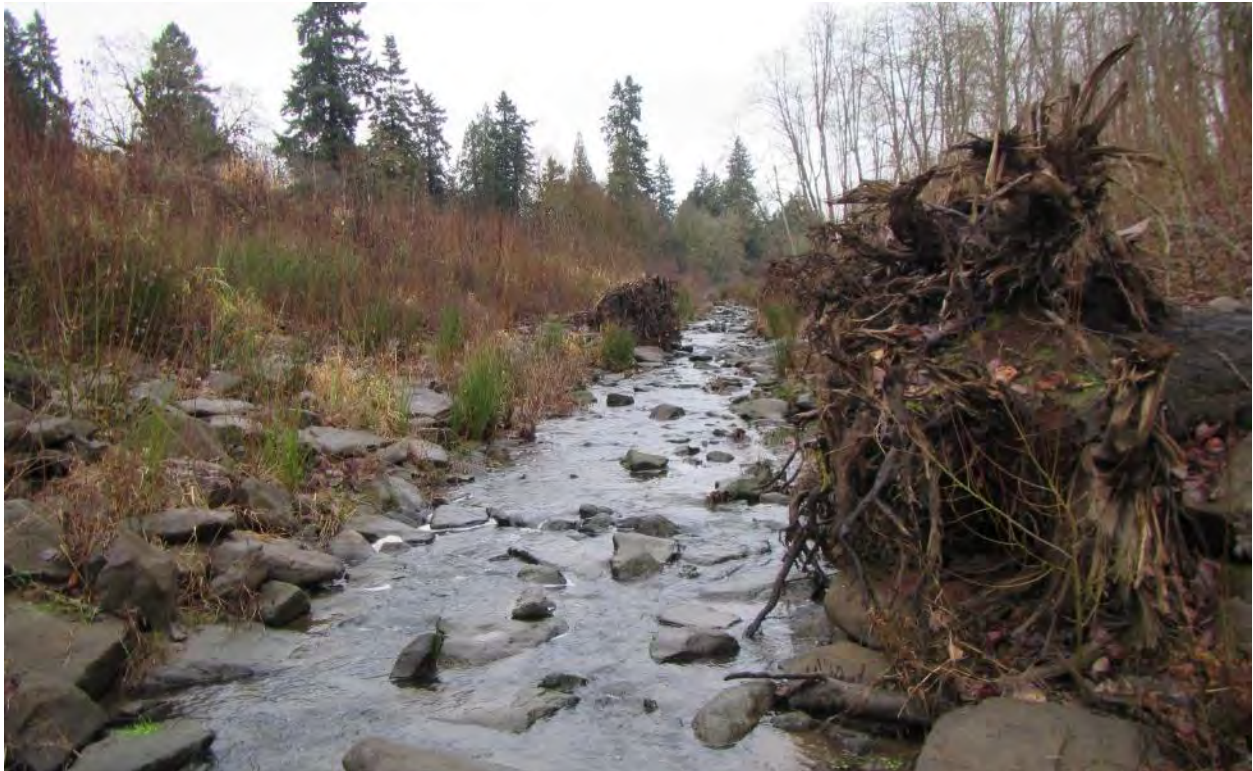
Figure 76. Steep riffle in Rinearson Creek extending from the confluence with the Willamette River side channel up to the beaver dam, and part of previous restoration project in Rinearson Creek. Riffle substrates consist of relatively large, angular rock.

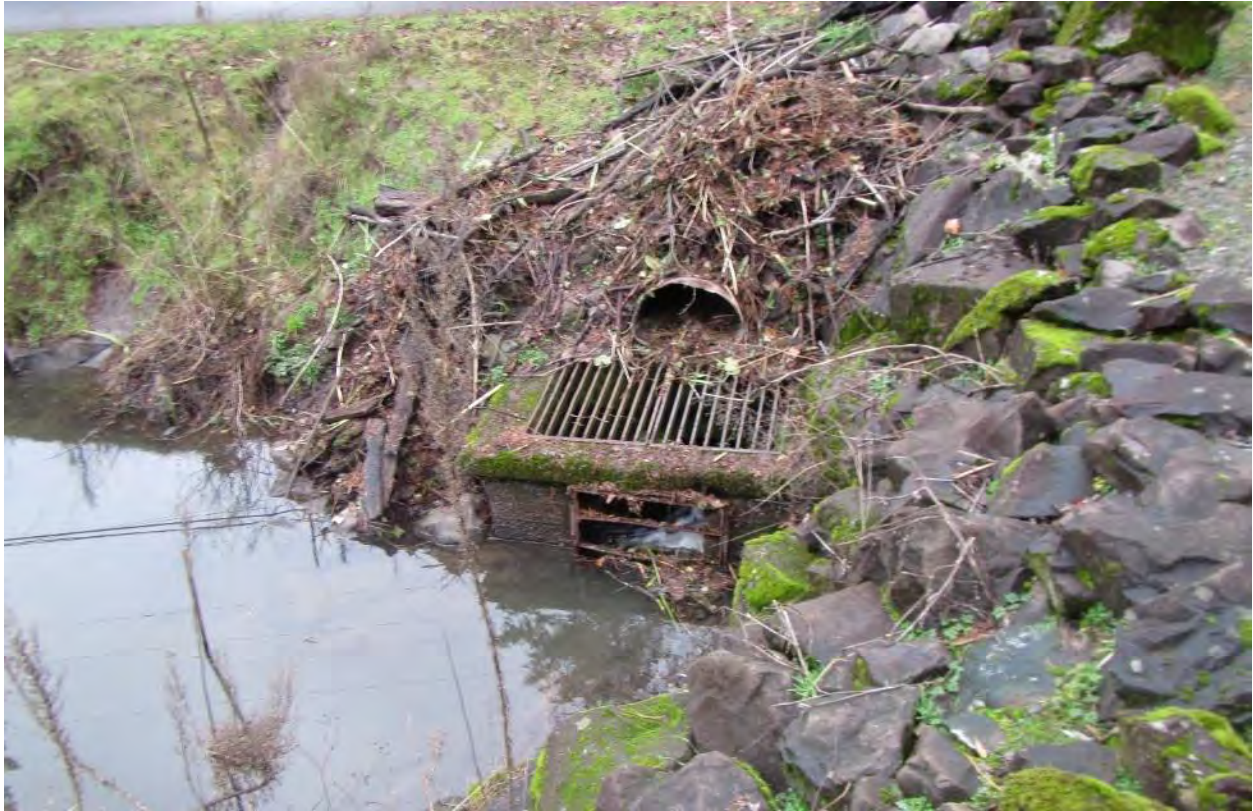
Figure 80. Upstream culvert inlet for SE River Forest Drive crossing, with debris rack and overflow culvert, substantial bank armoring, and debris accumulation. This culvert maintains River Forest Lake water surface levels.

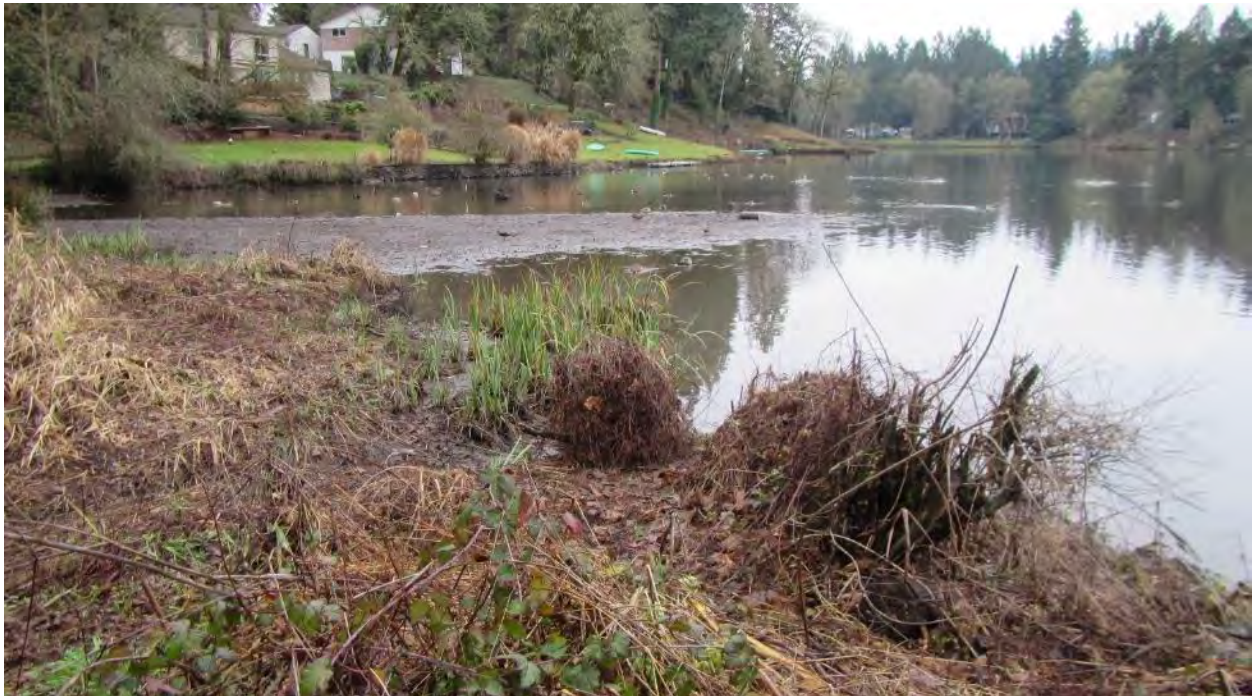
Figure 81. River Forest Lake. In foreground Himalayan blackberry invasive vegetation can be observed. In background, can see example of bank armoring along lake frontage and unvegetated, managed lawns.
