Oak Lodge Water Services District

Total Maximum Daily Load (TMDL) Implementation Plan

Annual Status Report

Rapid Bio-Assessment Report

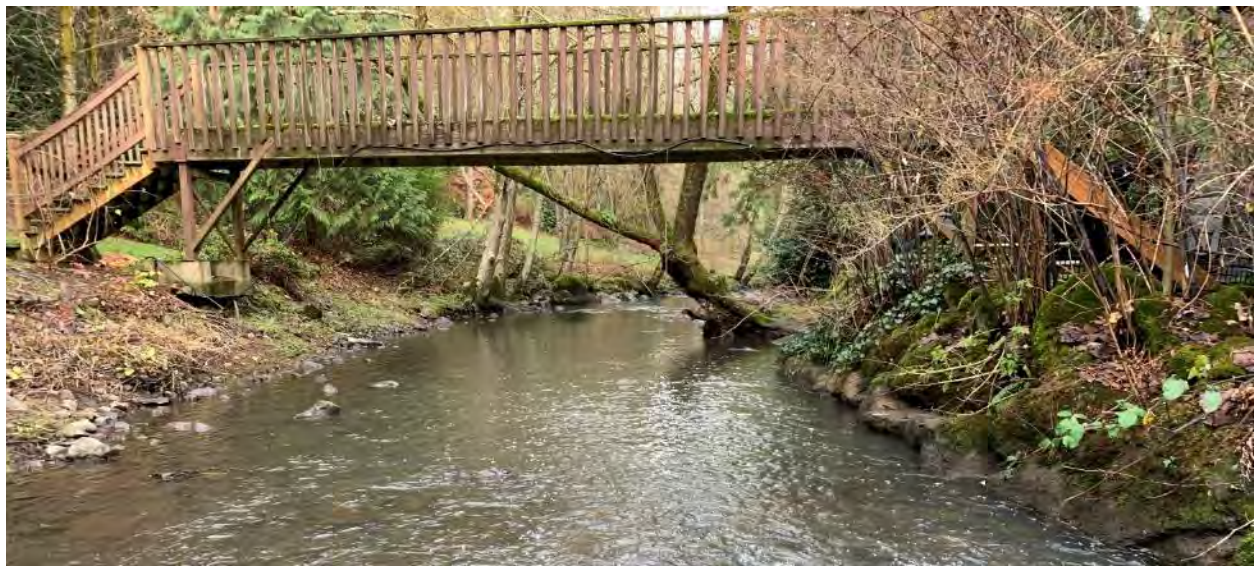
Three bridges cross over Kellogg Creek in the surveyed portion of Reach 1. A bridge appearing to be for pedestrian use only crosses the channel near approximately rKm 2.91 (Figure 16). A driveway bridge provides landowner access to a house near rKm 3.11 (Figure 17), and Keuhn Road crosses the channel near approximately rKm 3.55 (Figure 18). A stormwater outfall (No. 45014) is located on the river right bank near rKm 3.06 (Figure 19, Figure 20) and appears to create a deep scour pool from the flow. Anecdotal information from a landowner received during the field survey indicates fish may use this scour pool as a holding area during migration or prior to/after spawning just downstream.

Figure 16. A bridge appearing to be for pedestrian use only crosses the Kellogg Creek channel near approximately rKm 2.91.

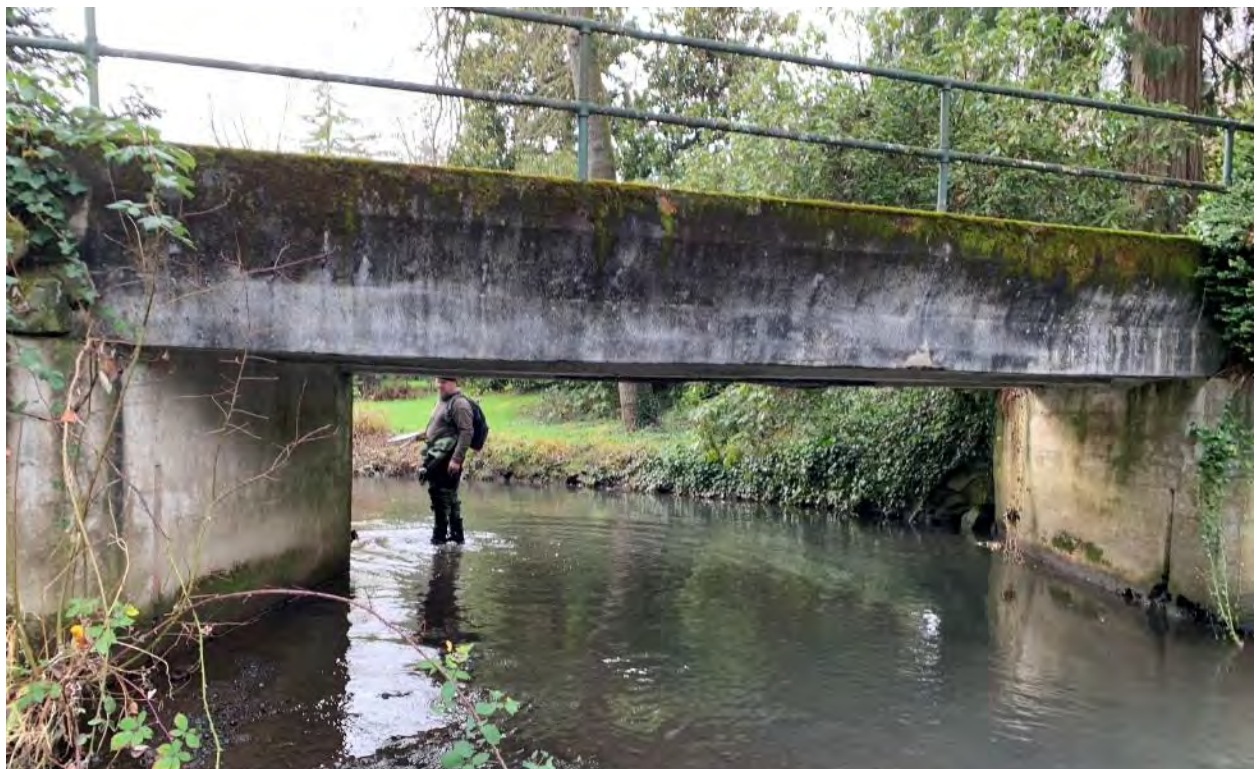
Figure 17. A driveway bridge provides landowner access to a house near rKm 3.11.

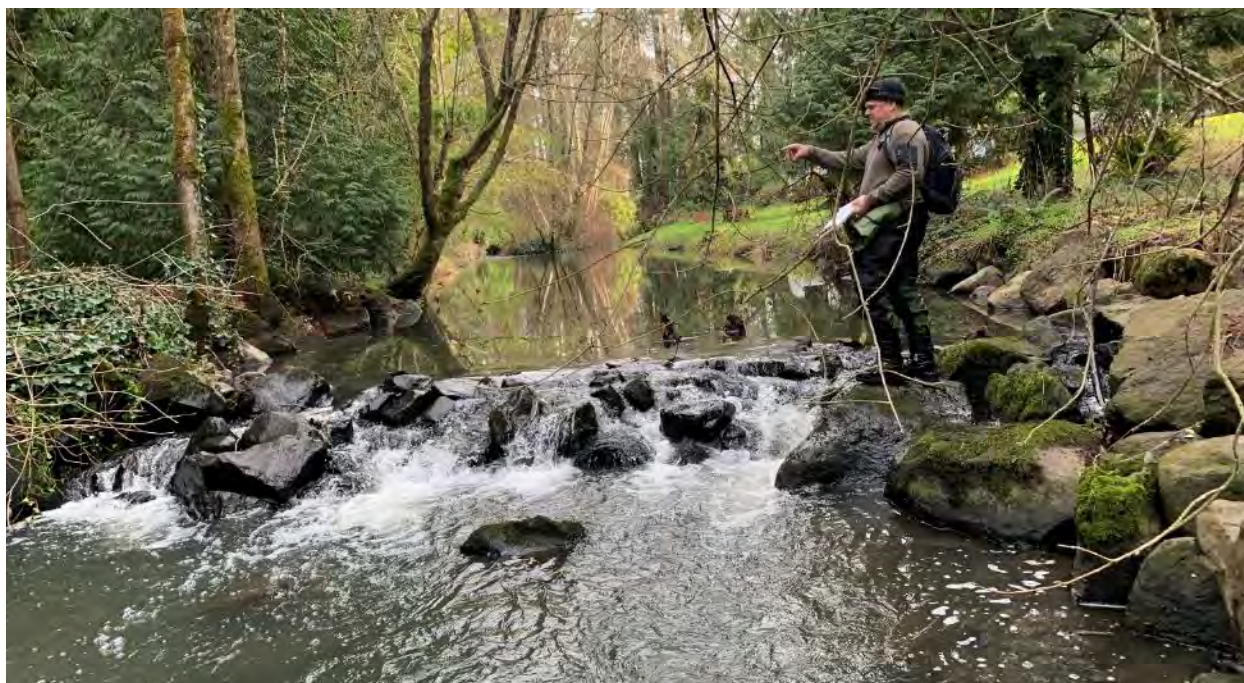
Stormwater infrastructure was also noted just upstream of the Keuhn Road crossing. At this location, a manhole is present at the edge of the river right channel and a pipe outlet was noted in the middle of the wetted channel (Figure 19). It is unclear the purpose of this pipe outfall. Large angular rock, riprap, appears to have been placed in the channel in this location, likely to protect the pipe infrastructure that may run across the channel. This riprap/pipe is noted as a barrier by ODFW (Barrier No. 34026).

Figure 19. Large angular rock located in the Kellogg Creek channel at rKm 3.55, just upstream of the Keuhn Rd bridge.

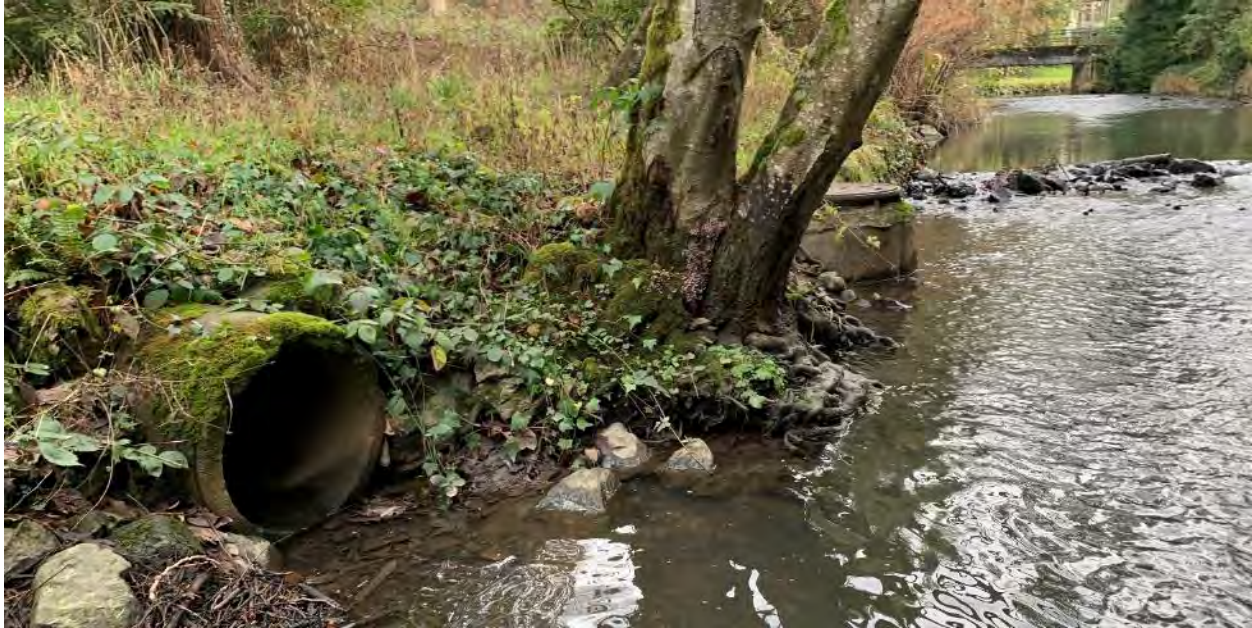
Figure 20. Stormwater outfall (No. 45014) located on the river right bank of Kellogg Creek near rKm 3.06.

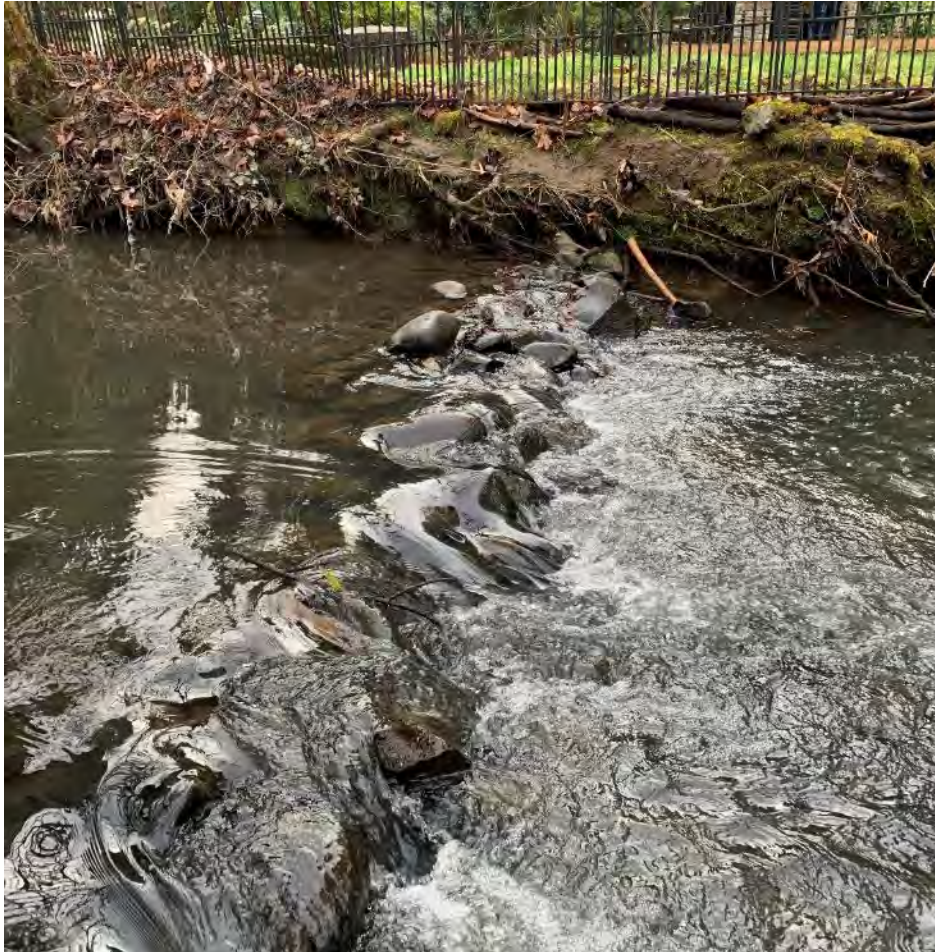
Previous habitat surveys in this reach of Kellogg Creek were conducted in 1997-1998, 2003, and 2008 (Friesen and Zimmerman, 1999; Tinus et al., 2003; Neerman and Vogt, 2009). Glide habitat dominated the reach in 1997-8 with approximately 80% of the surface area and fast water habitat in the remainder, or approximately 20% of the surface area. Surveys of this reach in 2008 indicated nearly half of the reach was a fast water unit (45%), with pools consisting of 25% of the reach habitat area. In 2019, surveys of Kellogg Creek show relatively consistent channel and valley characteristics throughout the surveyed portion of the reach, with the primary habitat units being long, often shallow, pool units (70%). These pool units appear to largely be formed by beaver dams or artificially-created rock weirs (consisting of cobbles and boulders presumably created by

landowners). The classification of habitat units as glides or pools by the survey crew may account for the difference in habitat composition over time, as it is unlikely to have changed all that dramatically in the past 20 years.

Figure 21. Example of small, man-made rock weirs within the Kellogg Creek channel in Reach 1. There are numerous of these present throughout the study area (and likely downstream of surveyed portion of reach as well).

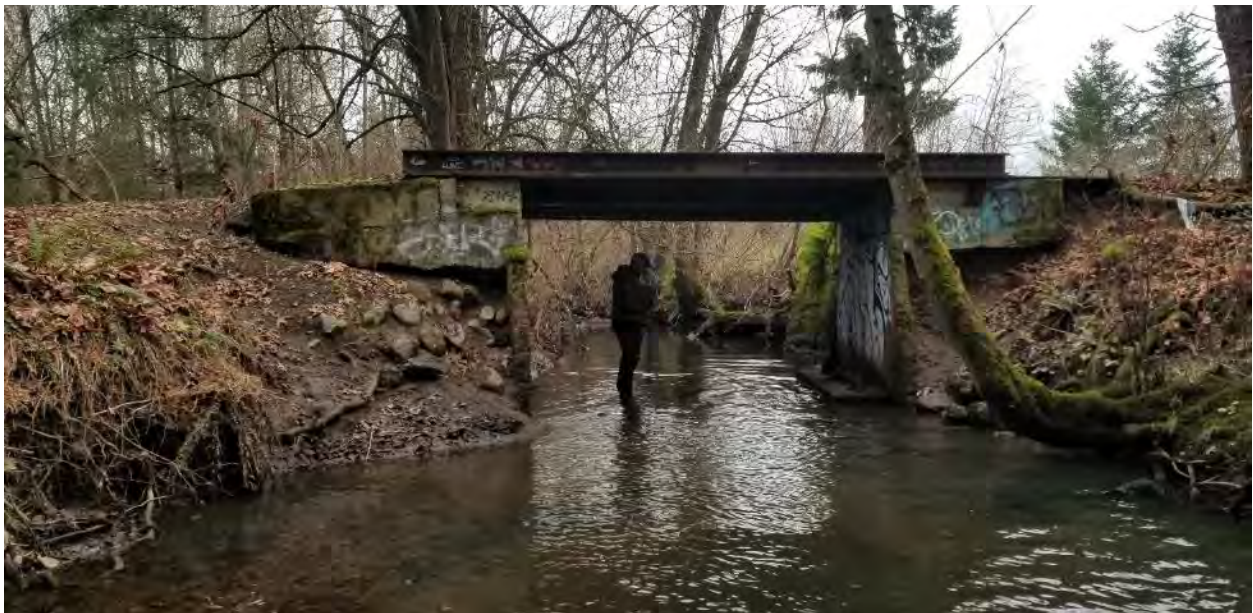
Infrastructure within or adjacent to MSC in Reach 3 includes the County’s water control structure (Figure 30) at rKm 2.2, a bridge that crosses over the channel, appearing to act as a flow constriction, near approximately rKm 2.5 (Figure 31), and an historical concrete bridge abutment near rKm 3.6 (Figure 32).

Figure 31. Bridge that crosses over the MSC channel in Reach 3, appearing to constrict flow, near approximately rKm 2.5.

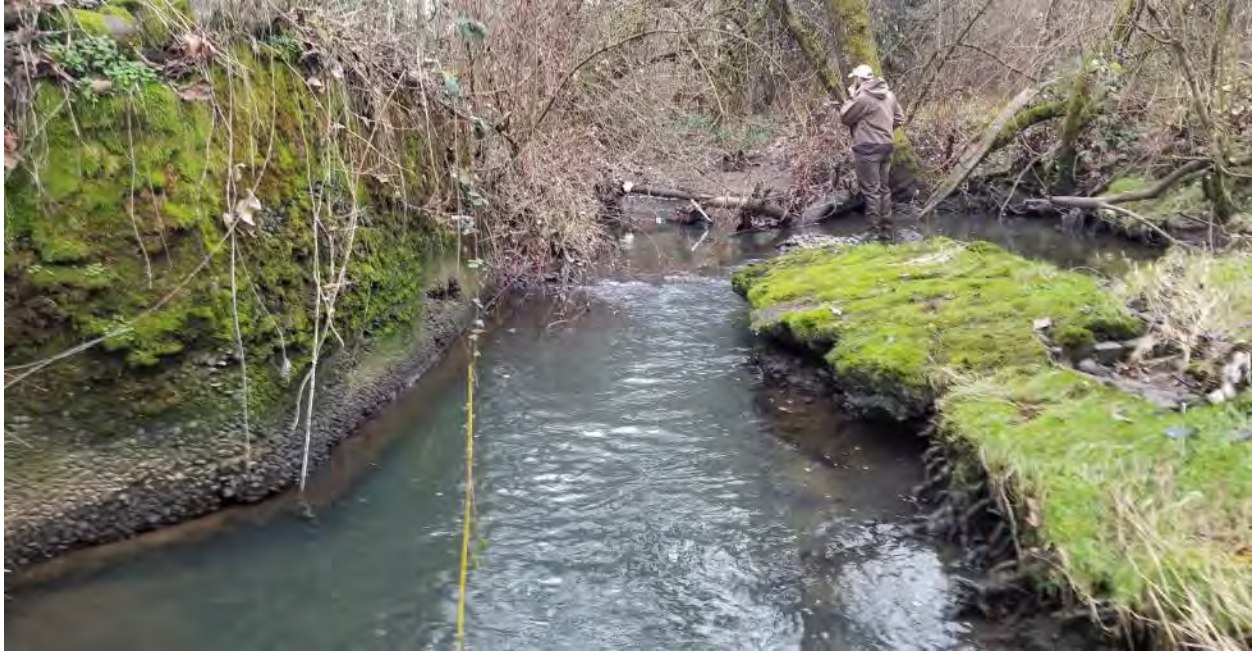
Figure 32. Historic bridge abutment in channel constricting flow near rKm 3.6.

reach. An abandoned bridge fell into the channel and constricts the channel as the old deck remains in the center of the stream. The abutments are left in place and erosion beneath will eventually cause them to fall into the channel, likely creating a more significant channel constriction.

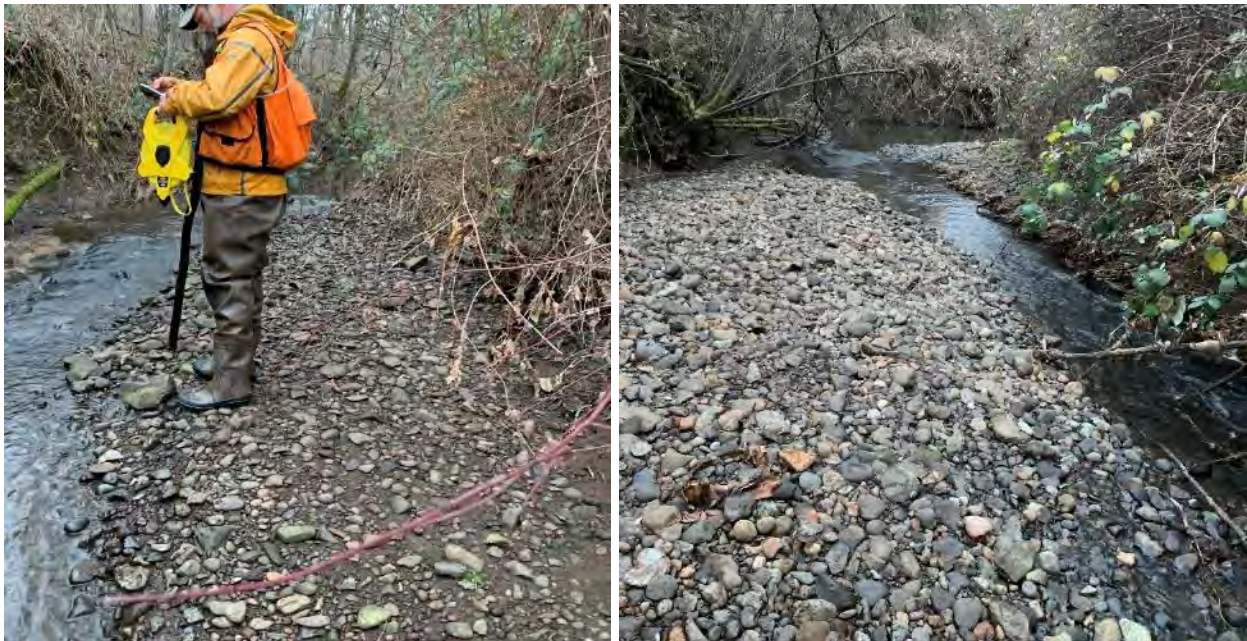
Three locations in the reach were identified as potentially suitable spawning areas, near rKm 4.63, rKm 4.69, and rKm 4.8 (Two of the sites identified are shown in Figure 33).

Figure 33. Examples of locations identified as potentially suitable spawning areas due to appropriate channel conditions, substrates, etc.

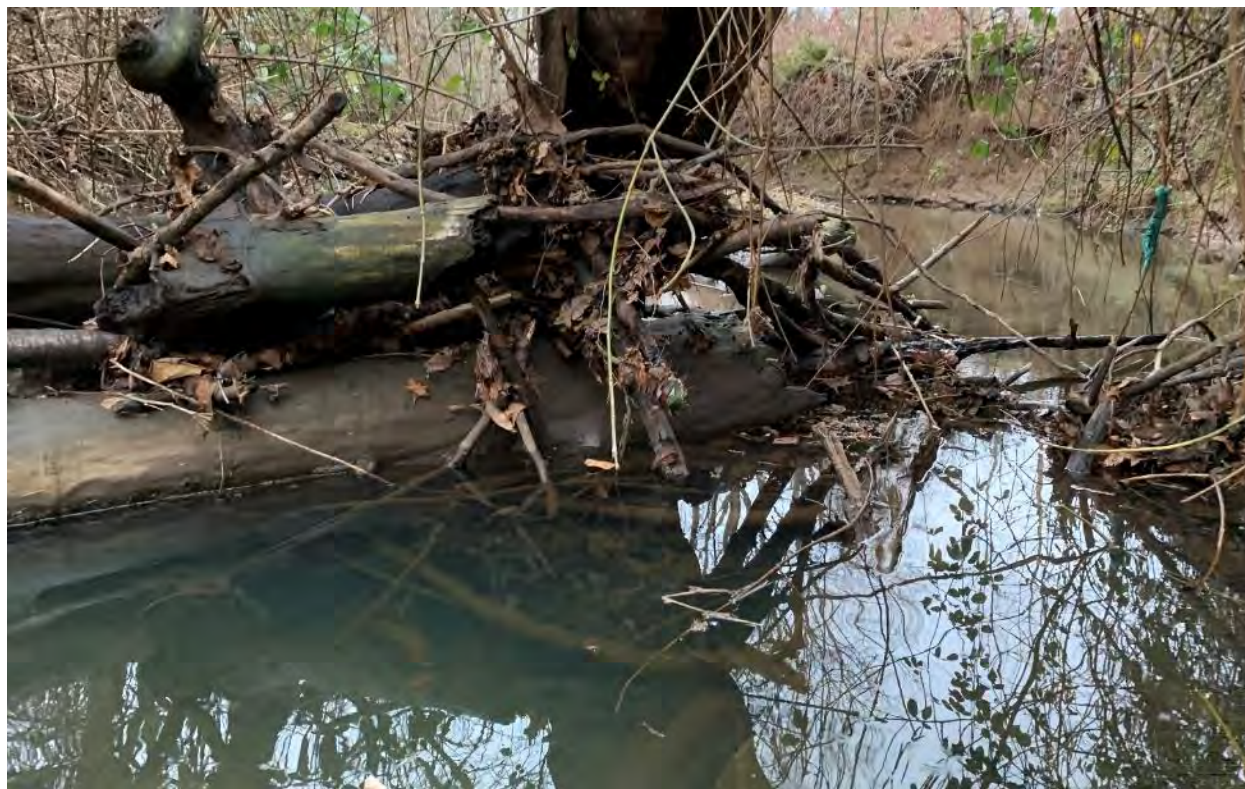
complexity rank among all streams surveyed was 1.4. Two pools received a score of 4, and another two pools received a score of 3. These pools with high complexity rankings were the pools with some of the highest residual depths. Pool cover averaged 20.6% for the reach, with a maximum of 50% cover in one of the pools.

Figure 38. Photo from rapid bio-assessment field investigation, of pool with one of the highest complexity ratings.

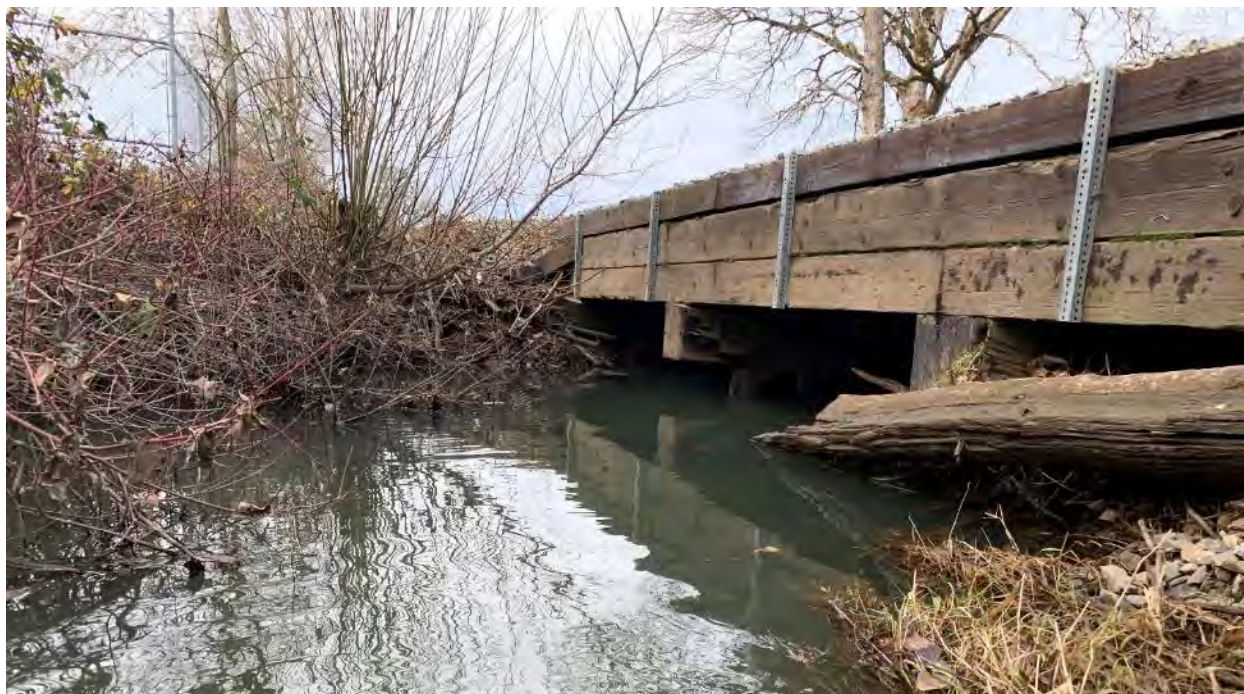
Figure 43. Downstream railroad bridge crossing MSC at the start of Reach 5 (rKm 3.82).

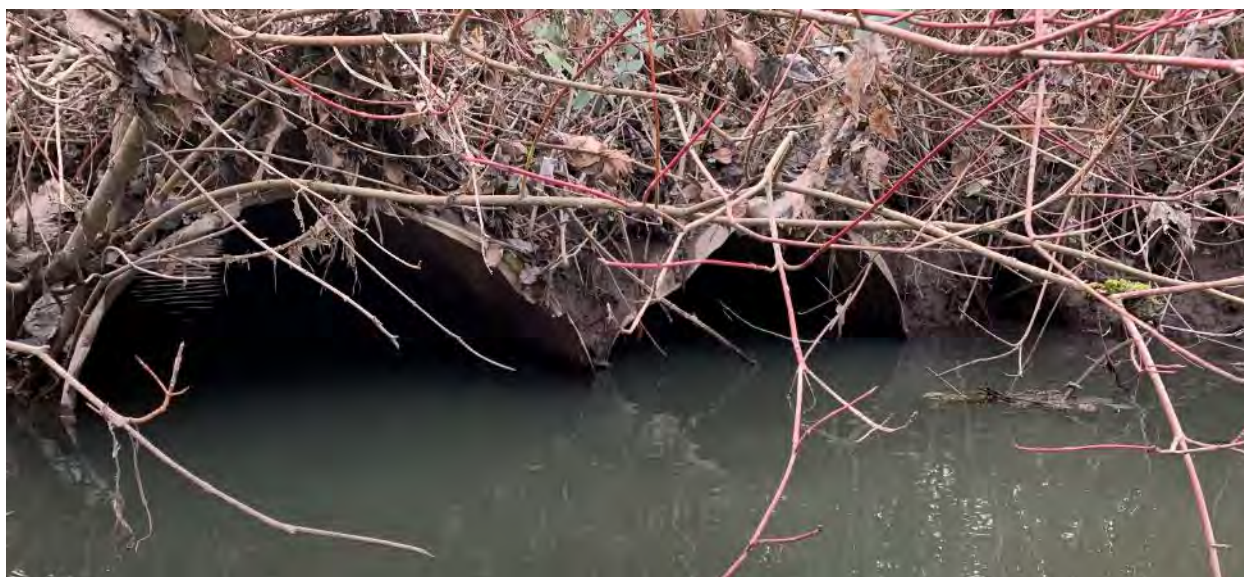
Figure 44. Culverts connecting Dean Creek to MSC near rKm 3.82.

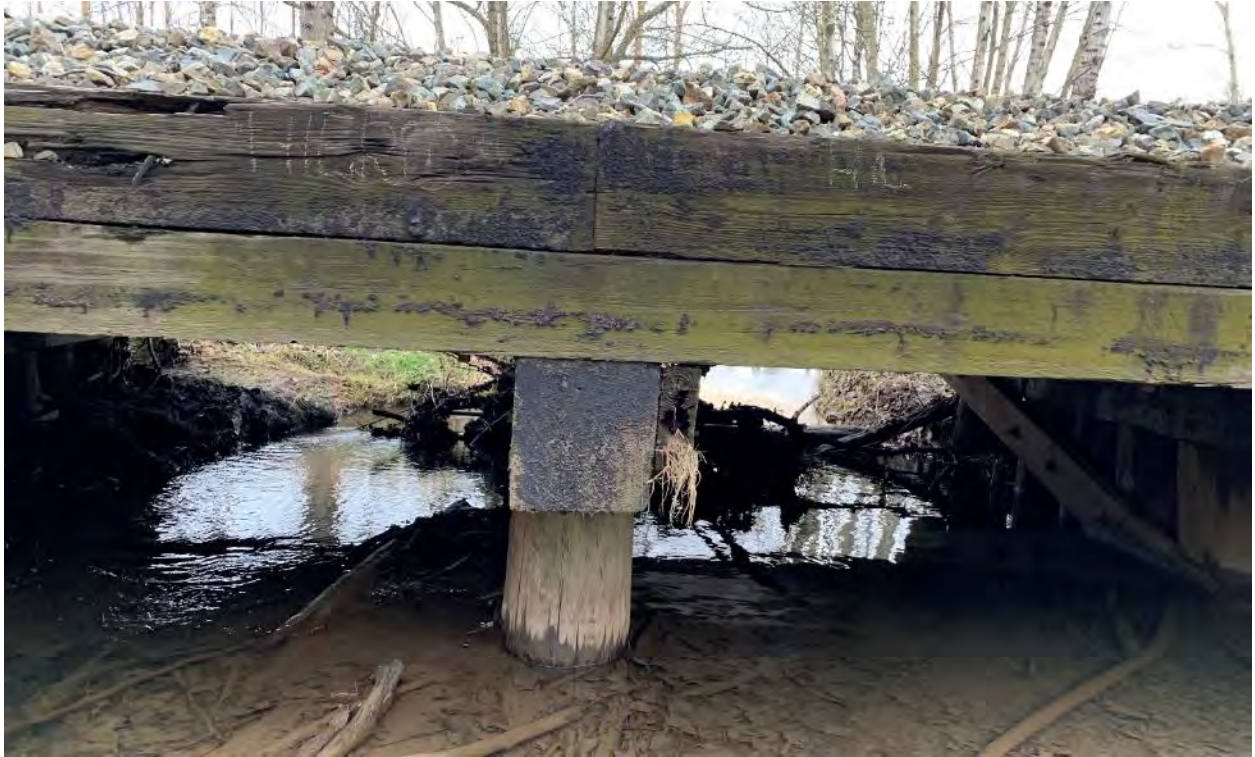
Figure 45. Upstream railroad bridge crossing MSC at the rKm 4.09.

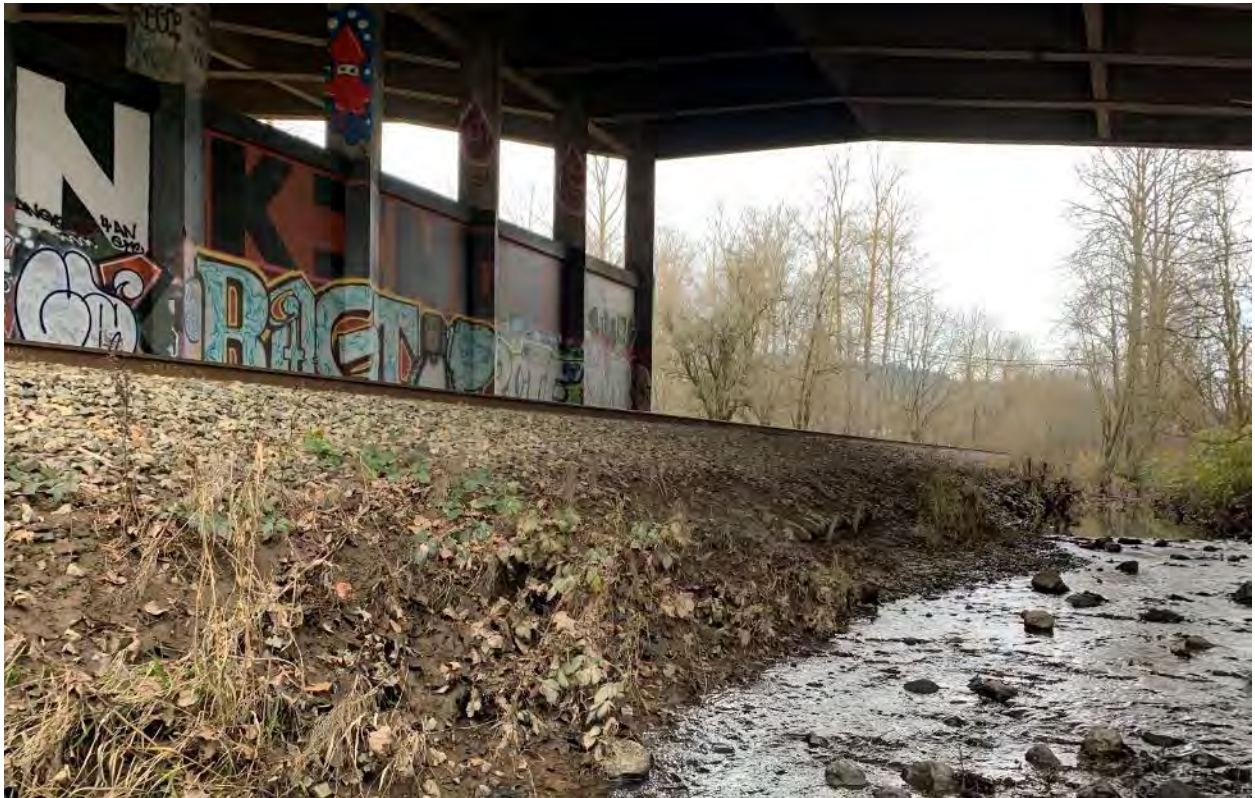
Figure 46. MSC adjacent to railroad, under the large 82nd Ave/Hwy 213 bridge.

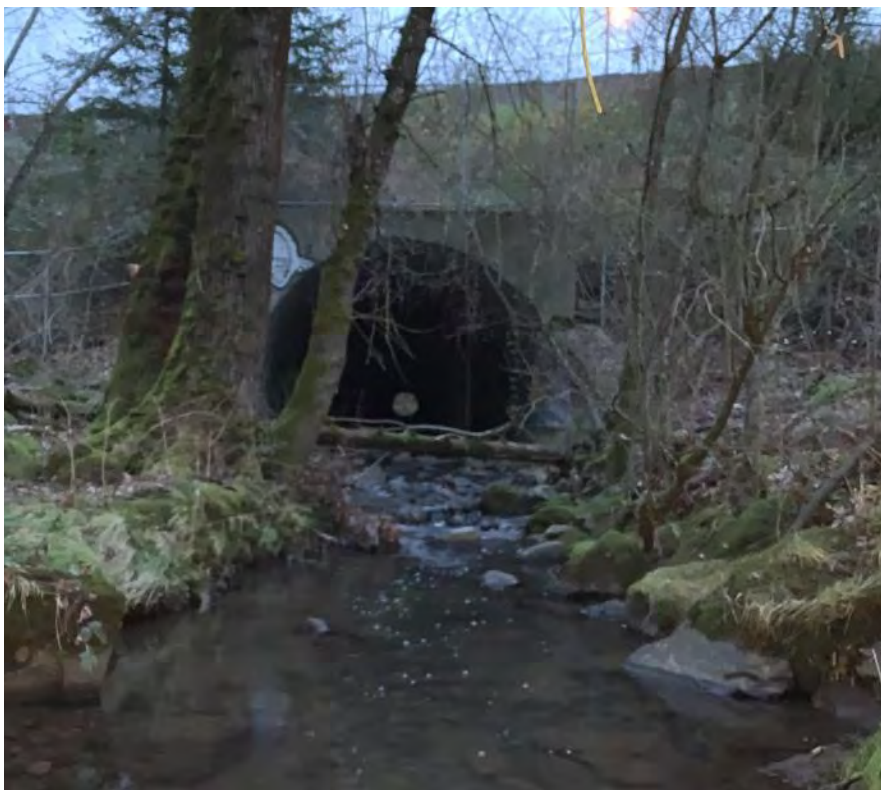
Figure 48. I-205 culvert outlet; the upstream extent of MSC Reach 5.

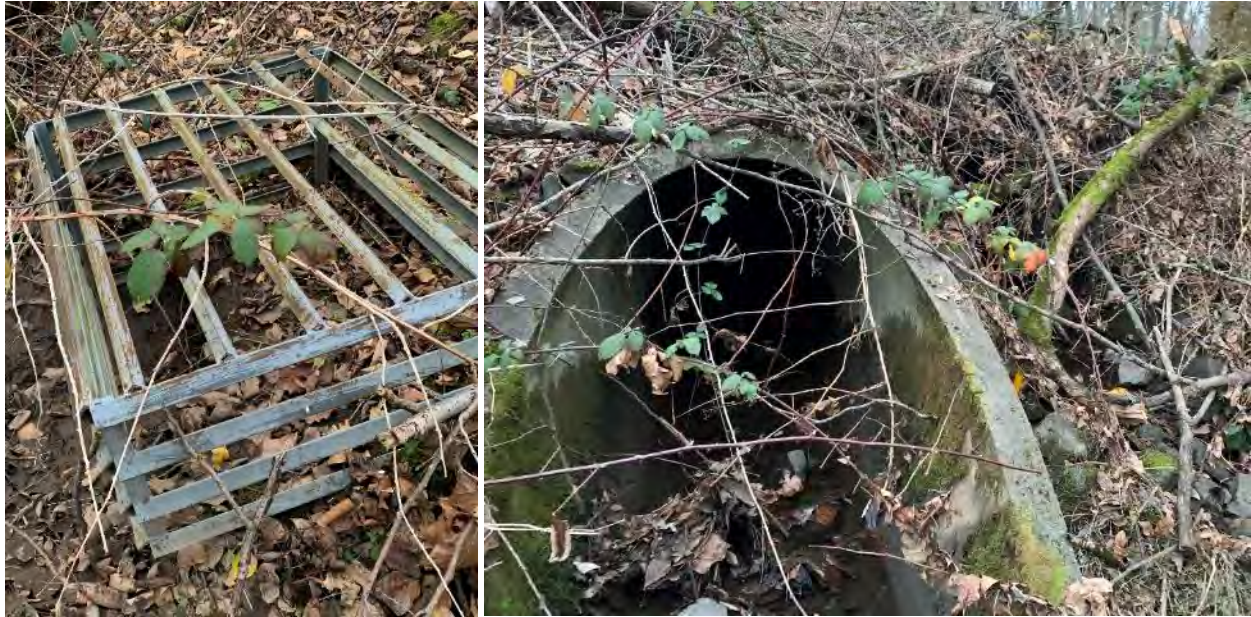
Figure 49. Example stormwater outlet/inlet (?) with a debris rack (left) and two stormwater outfall culverts in MSC Reach 5.

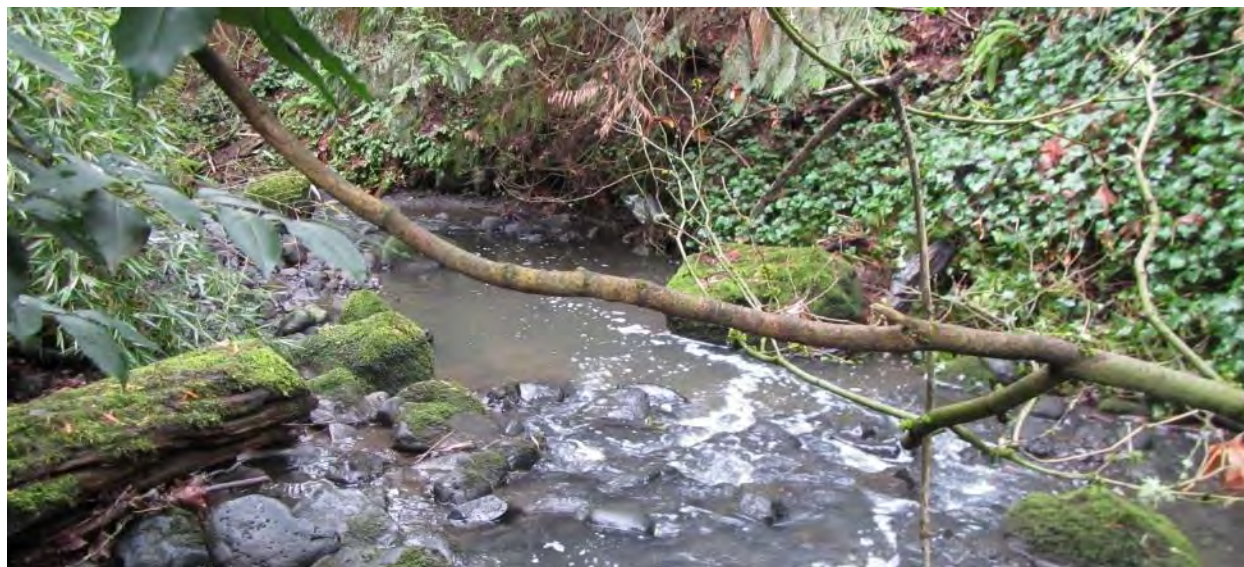
Pool quality for salmonid habitat was low, with an average pool complexity rank of 1.0 (scores may range from 1 to 5), while the overall average pool complexity rank among all streams surveyed was 1.4. Both pools received a score of 1. Pool cover averaged 37.5% for the reach, though there was substantial variability between the two pools (one had 75% cover, the other had 0% cover).

Figure 55. Pool habitat in Boardman Creek (looking downstream at pool in mid-ground of photo).

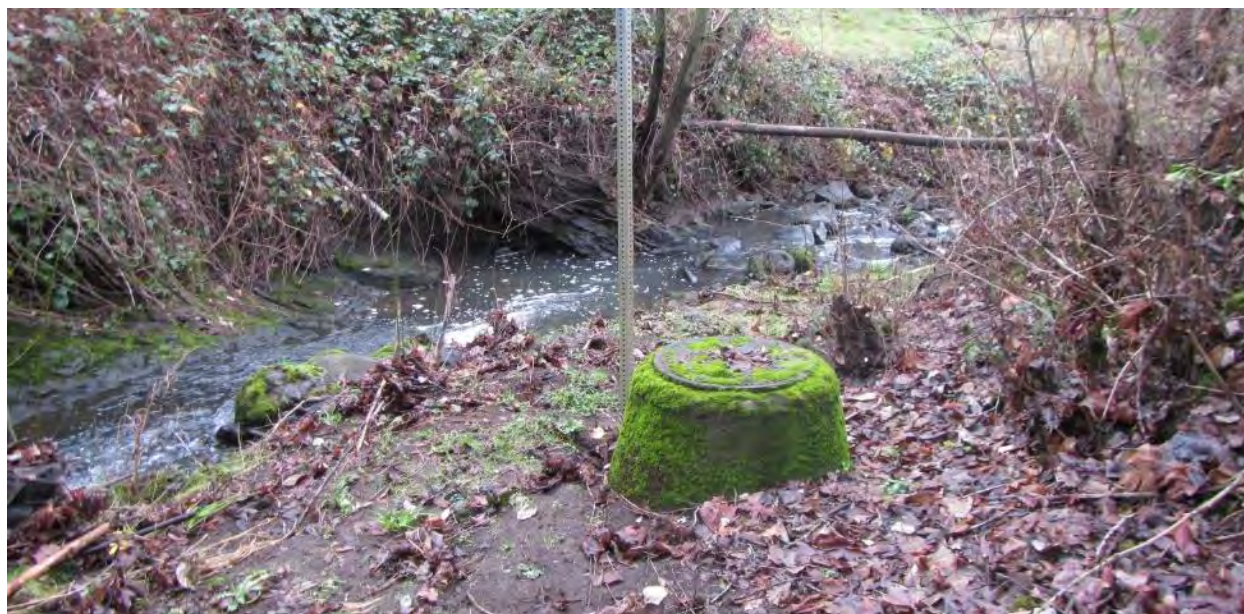
The primary infrastructure present in this reach was the stormwater tank located on river right and the manhole located in the middle of the wetted channel near rKm 0.1 in Boardman Creek (Figure 60, Figure 61). Another stormwater manhole was located on the river right floodplain near rKm 0.07 (Figure 62).

Figure 62. Stormwater manhole located in the river right floodplain near rKm 0.07 of Boardman Creek.

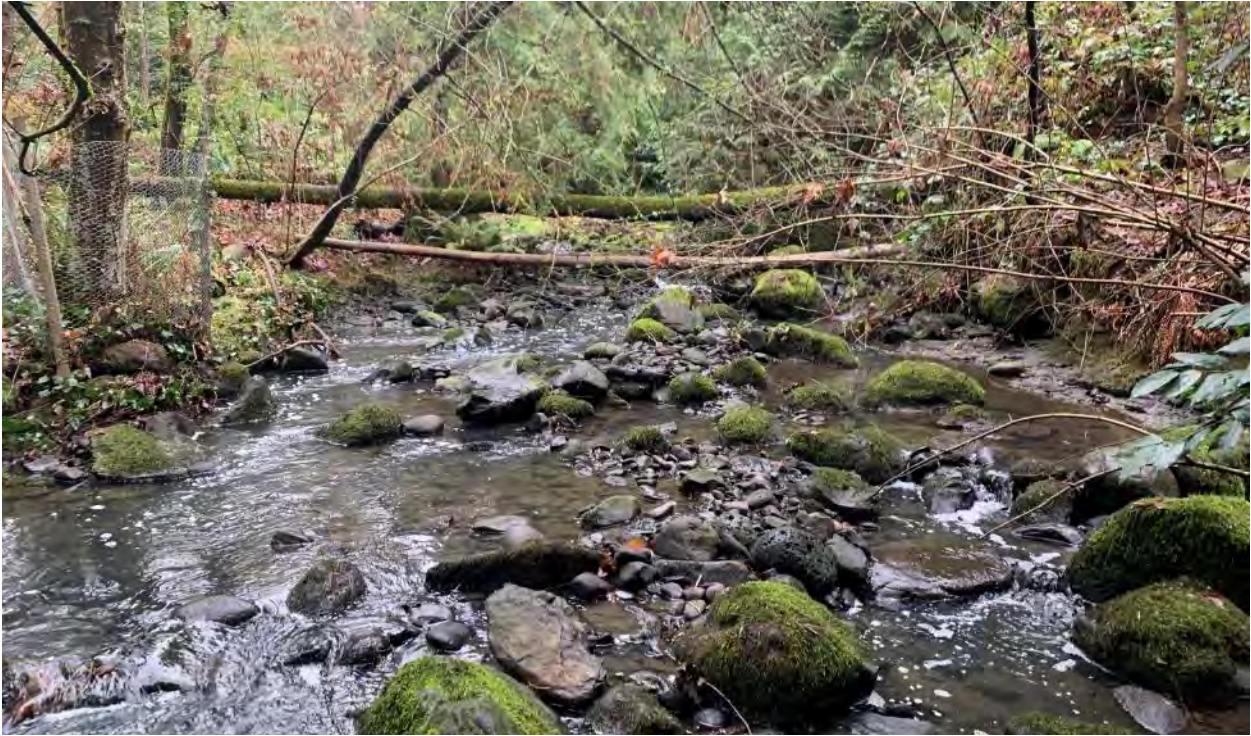
Figure 63. Boardman Creek, looking upstream from upper extent of field survey.

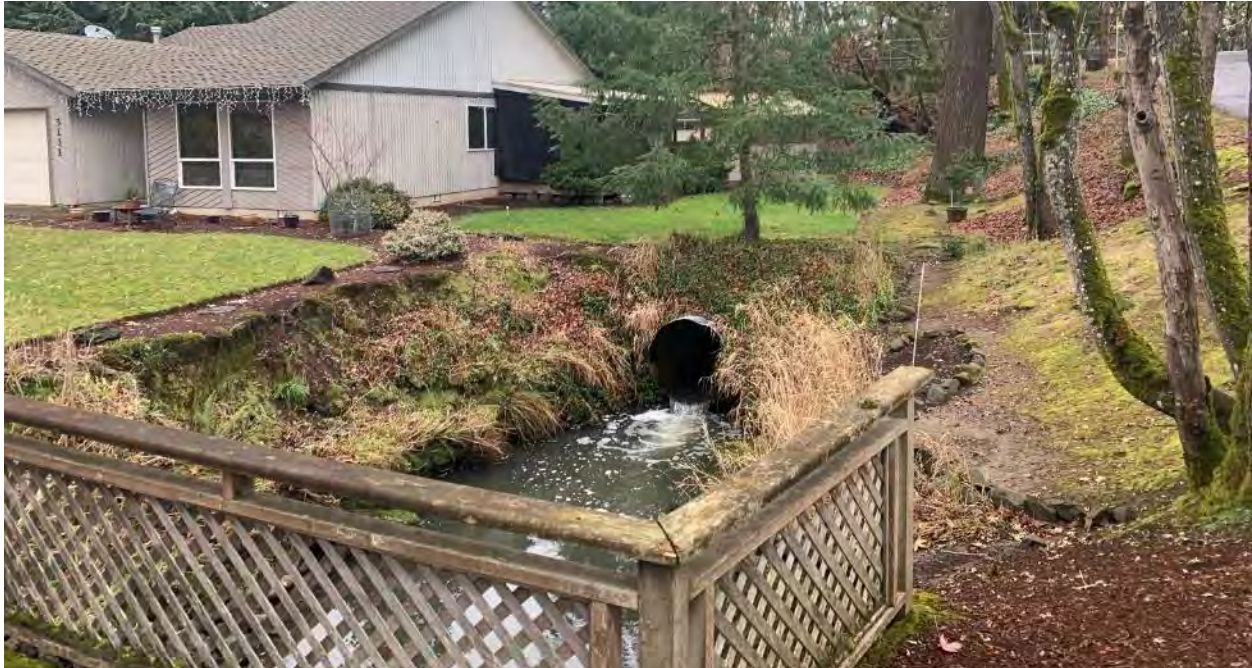
Figure 65. *Culvert upstream of SE Walta Vista Rd that is presumed impassable for fish (culvert extends upstream through SE River Road in background of photo, culvert length is an estimated 80 or more meters).*

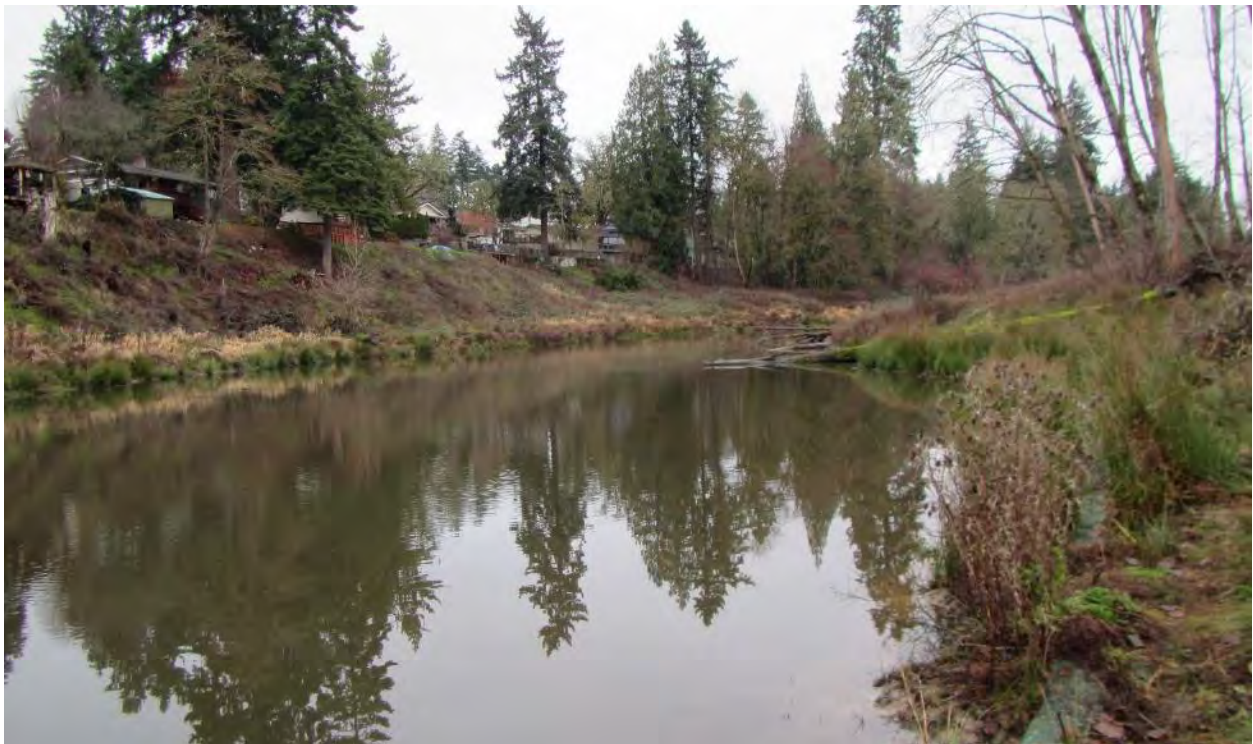
Figure 70. The large beaver pond pool unit recorded in Rinearson Creek, standing at the beaver dam and looking upstream.

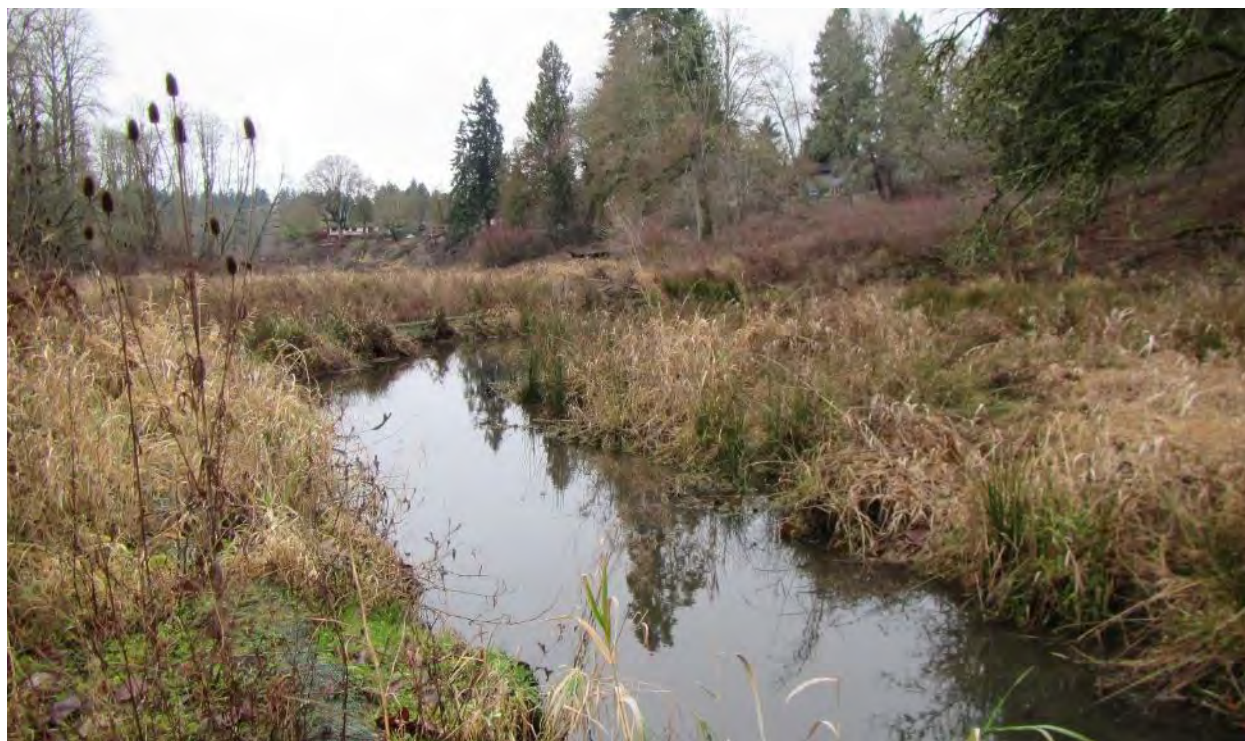
Figure 71. Pool habitat unit in Rinearson Creek.

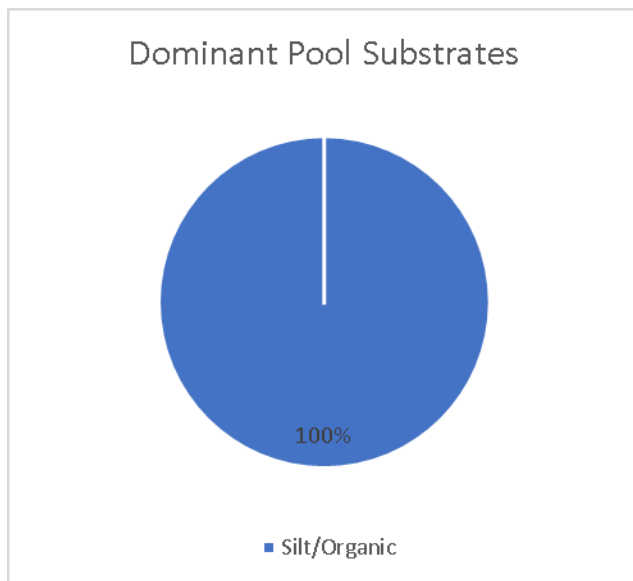
material made up the entirety of the two other substrate estimates in the middle and upper portions of the reach (Figure 73). Dominant substrates in pool units were entirely silt/organic materials (n = 4) (Figure 74).

Figure 74. Dominant pool unit substrates recorded within the surveyed portion of Rinearson Creek.

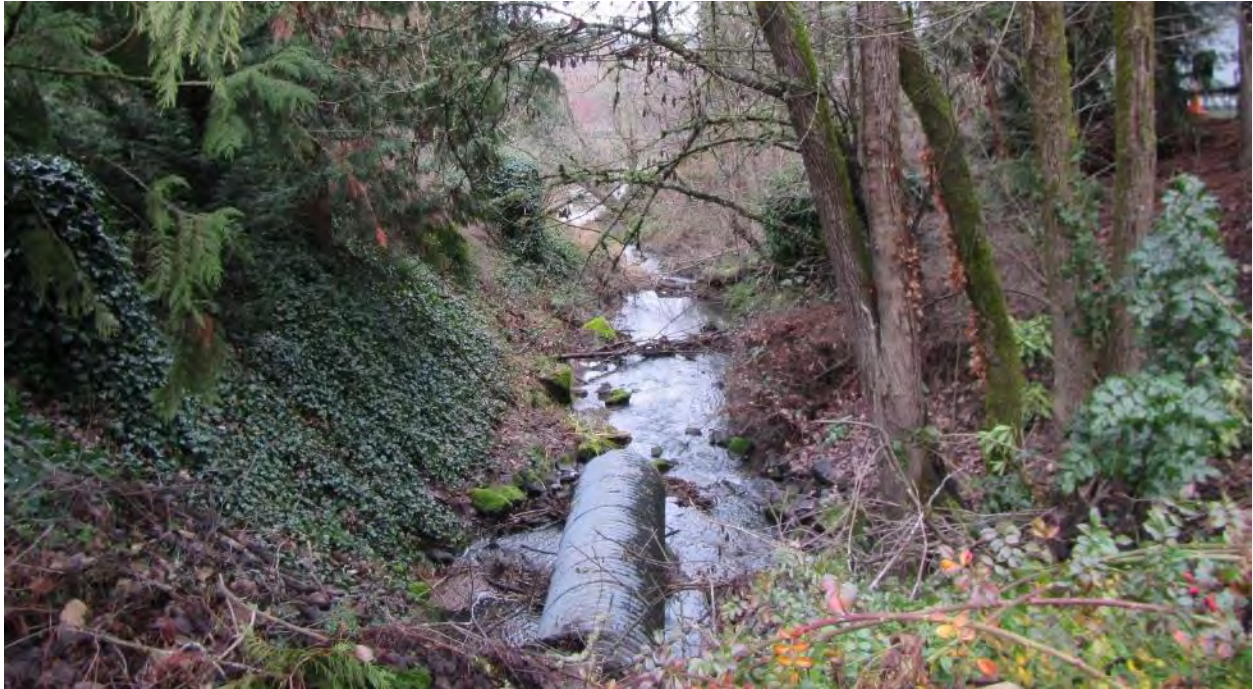
Figure 78. Standing on SE River Forest Drive, looking downstream at River Forest Creek channel out to confluence with Willamette River.

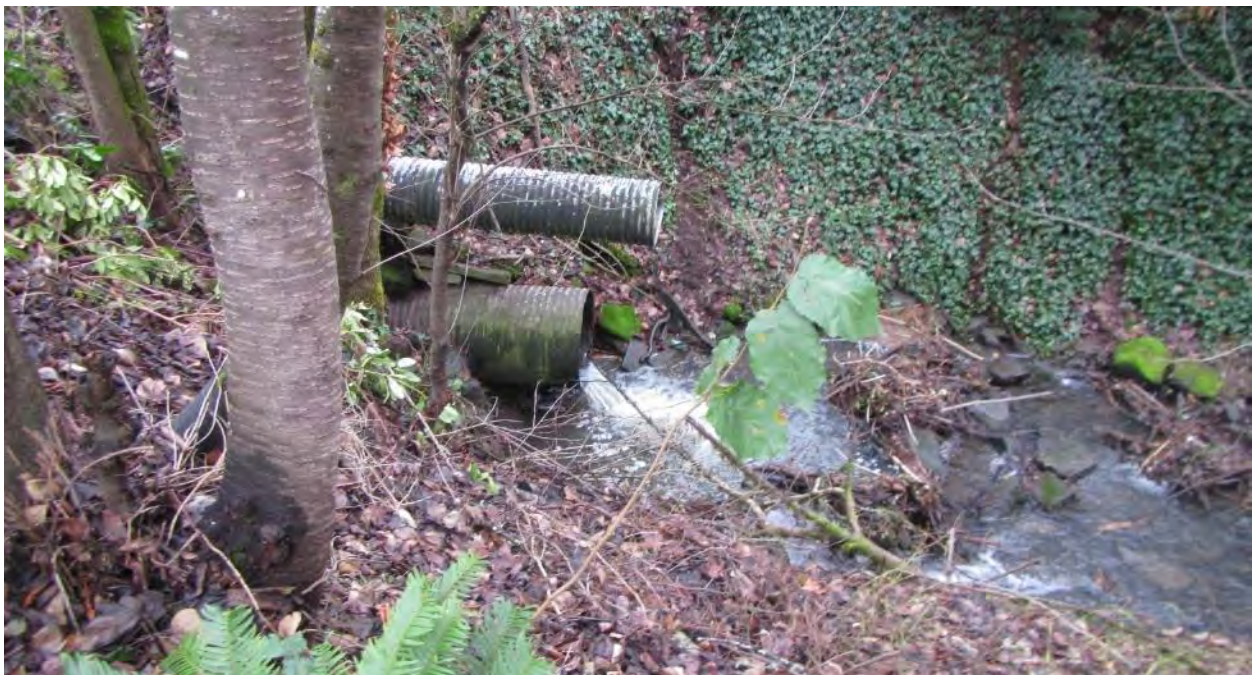
Figure 79. View of outlet of culvert through SE River Forest Drive from river left bank.

The culvert located at rKm 0.1 under SE River Forest Drive is a full fish passage barrier (Figure 79, Figure 80). Numerous other road crossings and channel modifications are present throughout the watershed.

0.2	Passage Improvement	River Forest Drive culvert replacement	Remove or replace River Forest Drive culvert to provide fish passage into River Forest Creek.	If this barrier was removed or replaced with a fish-passable culvert, additional projects upstream of this location may become higher priority/provide increased value for native species. Different project types, including channel habitat projects, may also be recommended as a result.
2	0.2 - 1.3	Large Wood	River Forest BDAs and Water Quality Enhancement	Place beaver dam analogue structures (BDAs) throughout River Forest Creek where feasible to attenuate flood flows, encourage water infiltration and water quality improvements to watershed.	Objective is to improve water quality coming out of River Forest and into Willamette through low-cost, straightforward methods.
3	0.8 - 1.06	Floodplain Enhancement	Wetland Enhancement	Increase wetland floodplain connection to main channel in existing open forested area.	Objective is to improve water quality coming out of River Forest and into Willamette.

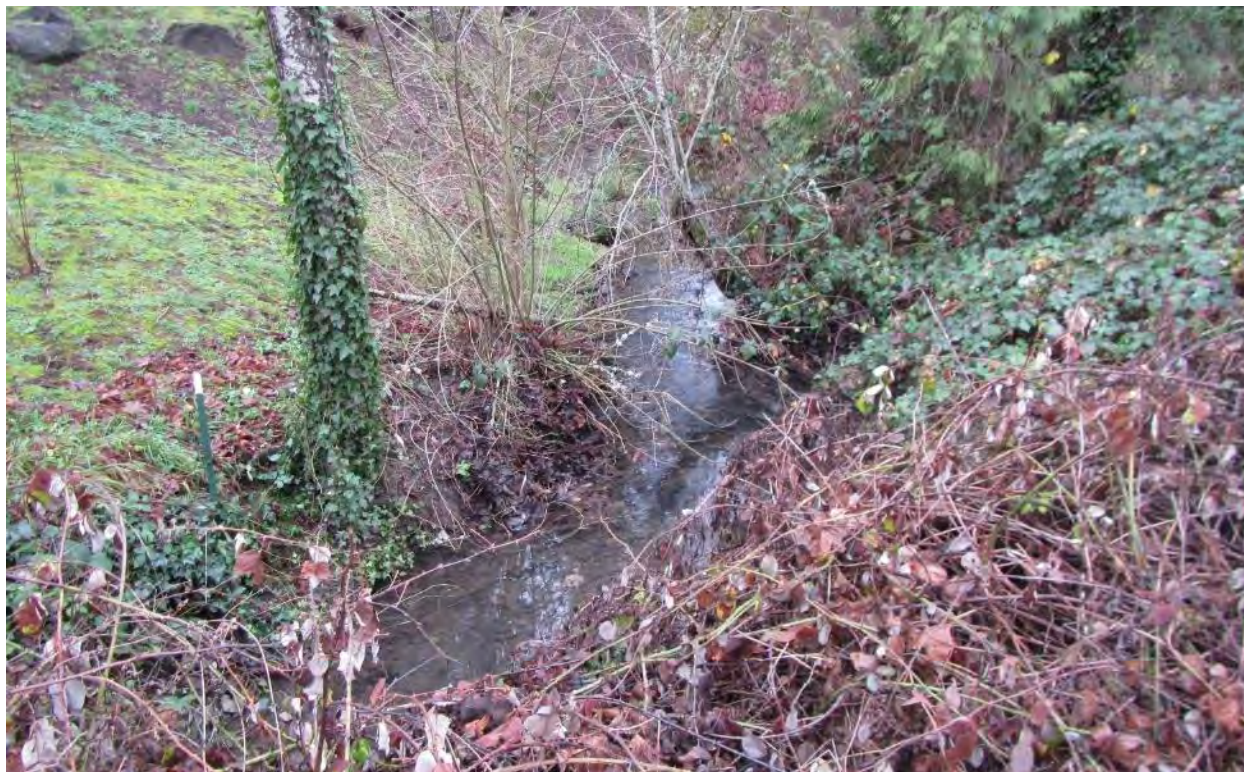
Figure 82. River Forest Creek at SE Fair Oaks Ave crossing (looking downstream).
