Oak Lodge Water Services District

Total Maximum Daily Load (TMDL) Implementation Plan

Annual Status Report

Rapid Bio-Assessment Report

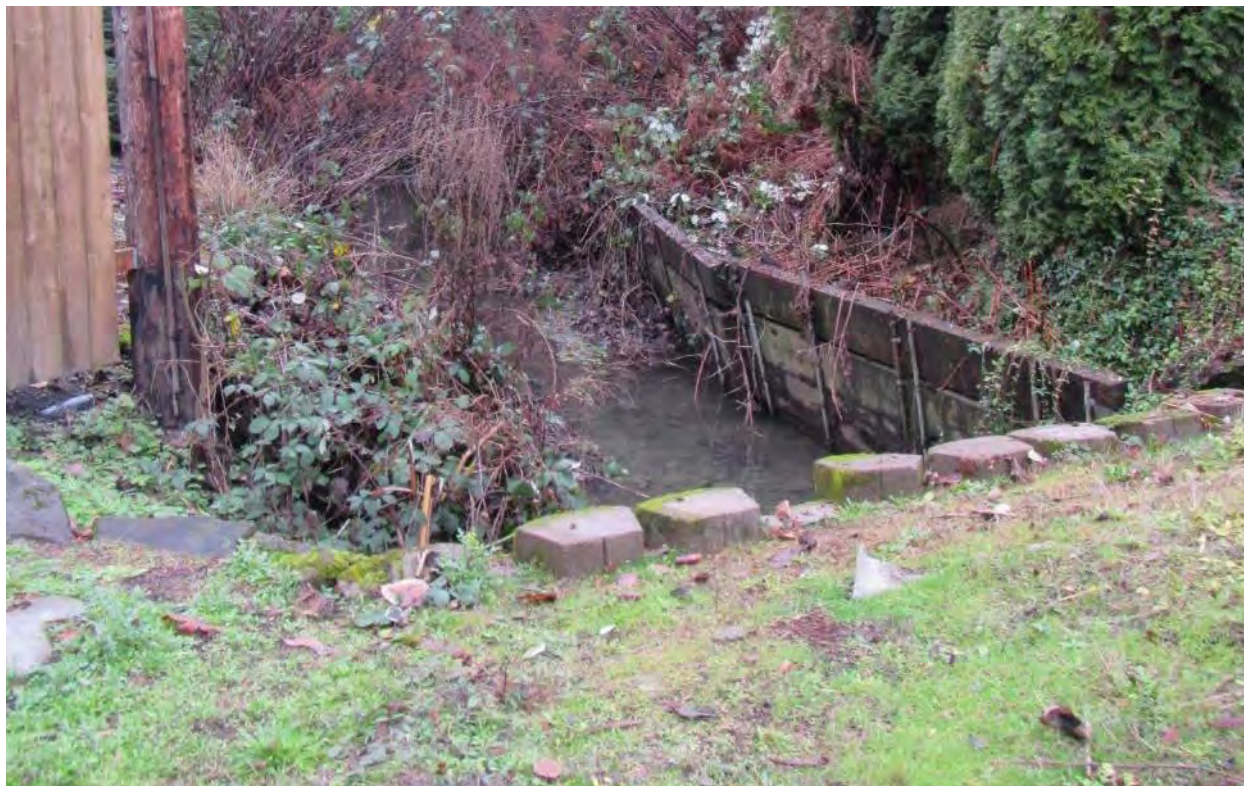
Figure 83. River Forest Creek at corner of SE Laurie Ave and SE Anspach St. (looking upstream).

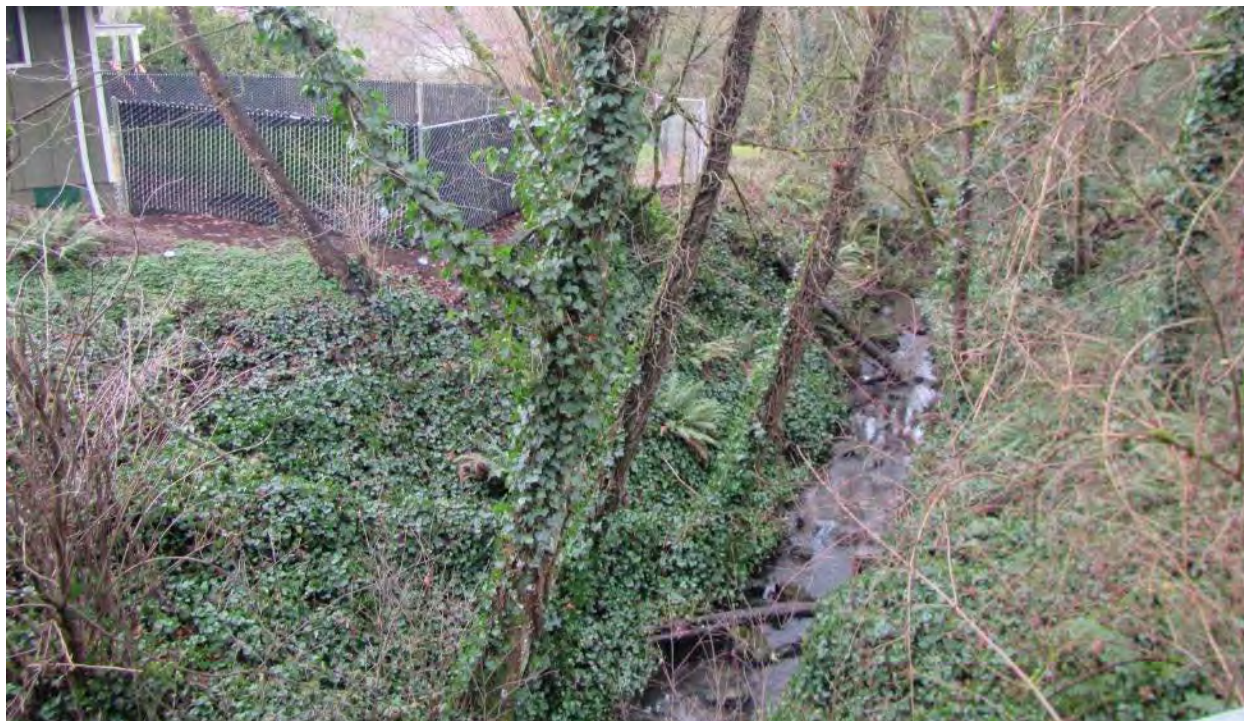
Figure 84. River Forest Creek at SE River Rd crossing (looking downstream)

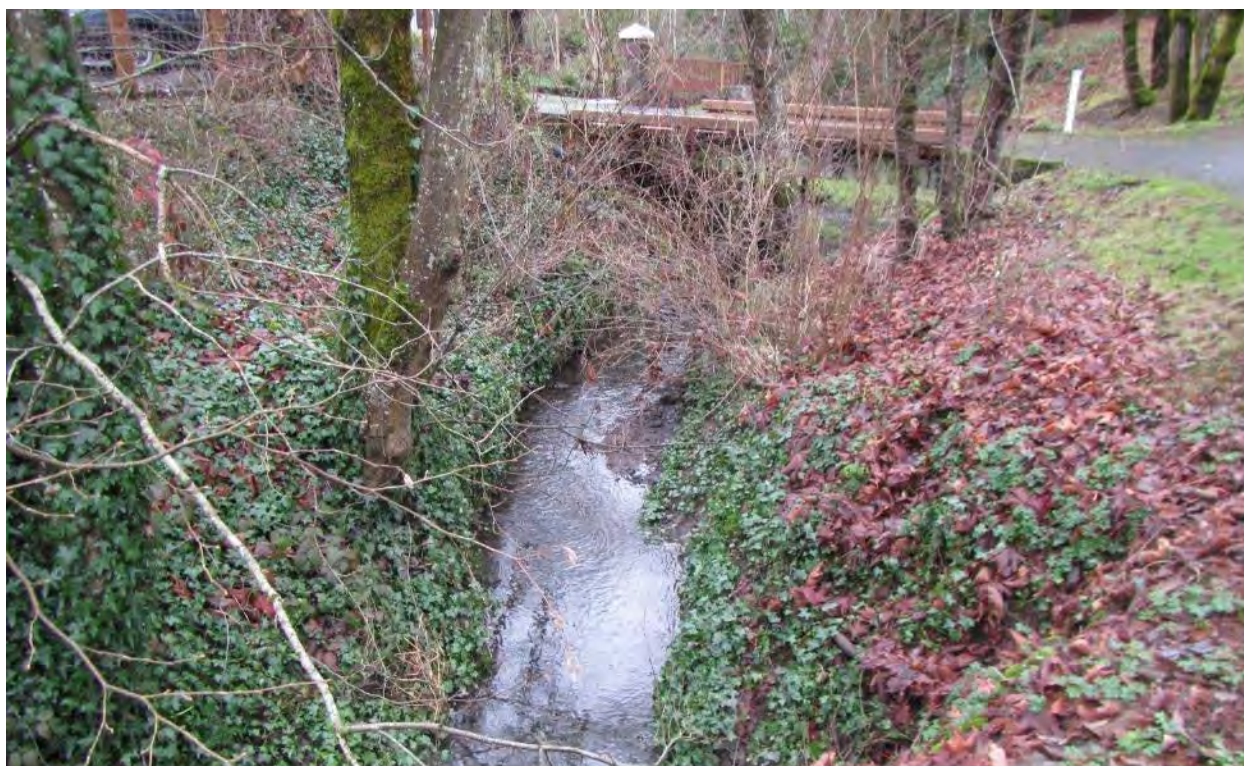
Figure 85. River Forest Creek at SE Fairoaks Ave crossing (looking upstream).
